National Transportation Safety Board Aviation Accident Final Report

Location:	LAFAYETTE, Louisiana	Accident Number:	CEN20MA044
Date & Time:	December 28, 2019, 09:21 Local	Registration:	N42CV
Aircraft:	Piper PA 31T	Aircraft Damage:	Destroyed
Defining Event:	Loss of control in flight	Injuries:	5 Fatal, 2 Serious, 2 Minor
Flight Conducted Under:	Part 91: General aviation - Executive/Corporate

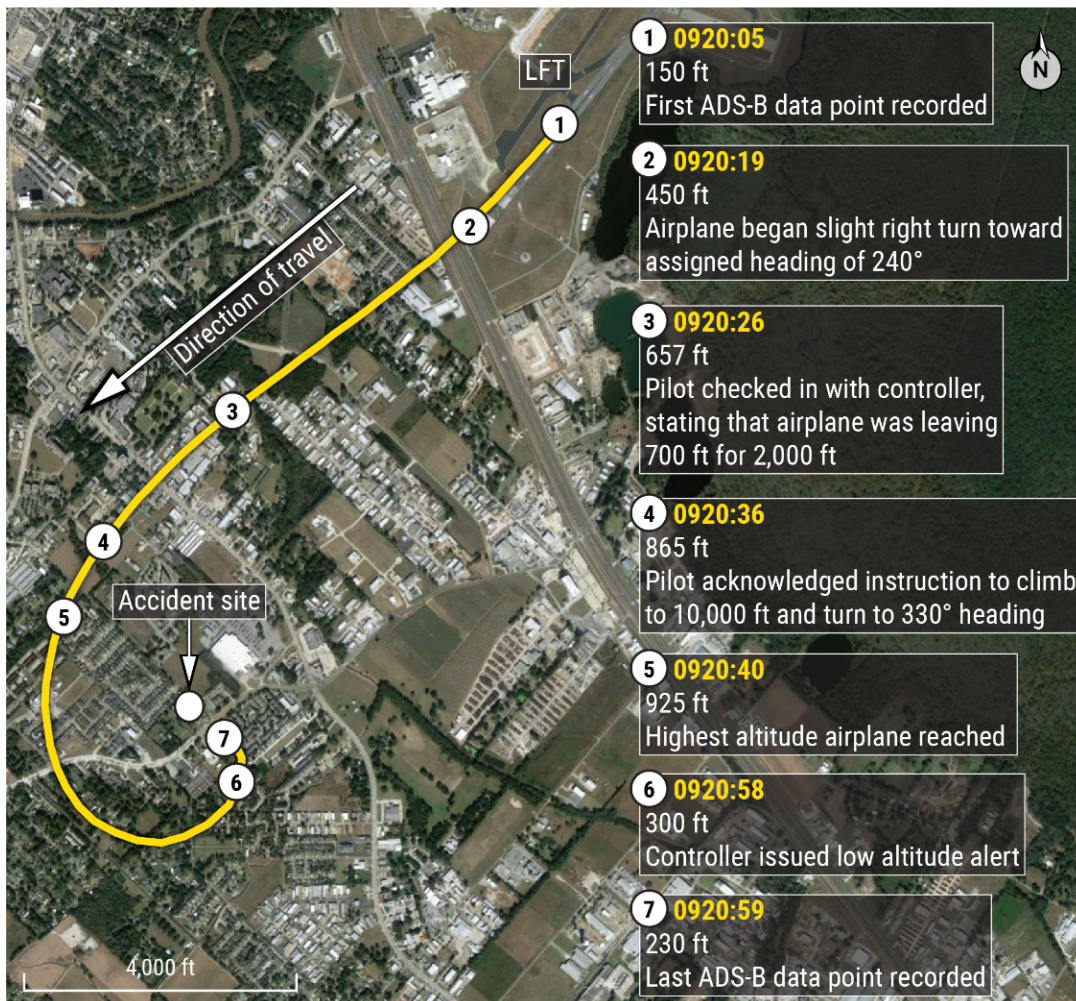
Figure 1. Flight track overview.

The Federal Aviation Administration (FAA) provided automatic dependent surveillance-broadcast (ADS-B) data for the accident flight. These data were used to calculate the airplane's performance, including its true altitude. (See the Tests and Research section of this report for more information.) The ADS-B data started at 0920:05 as the airplane climbed through an altitude of 150 ft. The airplane then began a slight right turn immediately afterward toward its assigned heading of 240°. The airplane reached a peak altitude of 925 ft from about 0920:37 to 0920:40 and then started a continuous descent toward the ground.

At 0920:58, the controller issued a low altitude alert, stating that the pilot should "check [the airplane's] altitude immediately" because the airplane appeared to be at an altitude of 300 ft. The pilot did not respond, and no mayday or emergency transmission was received from the airplane. The last ADS-B data point, at 0920:59, showed the airplane descending through an altitude of 230 ft. Figure 1 shows the airplane's flight track and key points based on aircraft performance calculations and radio transmission information.

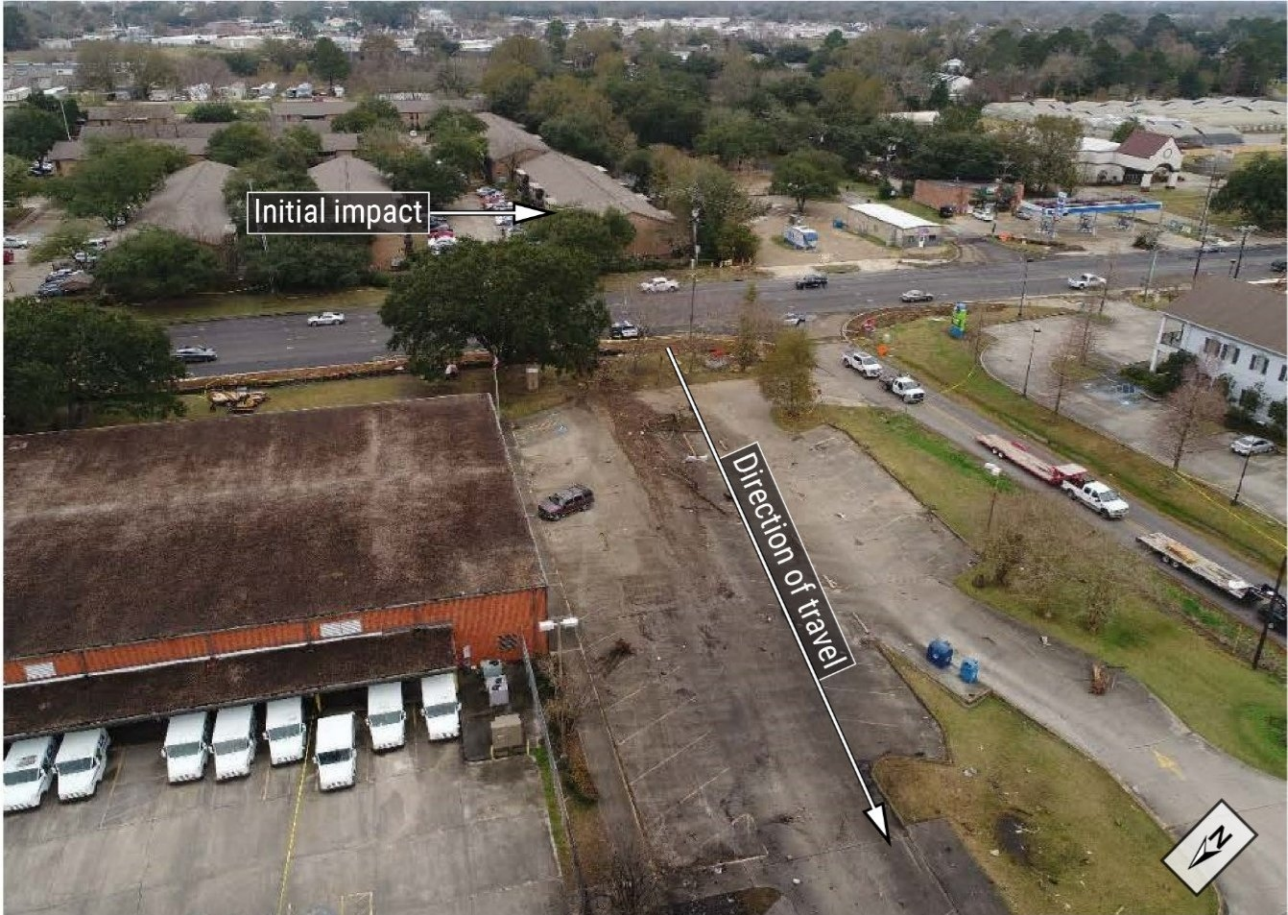
Figure 2. Initial impact point and direction of travel across post office parking lot.

The airplane impacted trees and transmission lines on the south edge of a road. A scar on the first tree that was struck indicated that the airplane’s attitude was right wing low. The first ground scar was located on the north edge of the road. The wreckage path, which included fragmented and burned pieces of the airplane and tree debris, extended 789 ft from the trees and transmission lines along a bearing of about 315°. The accident site encompassed the parking lot of a post office, as shown in figure 2, and an adjacent open field, as shown in figure 3. The aft fuselage came to rest at the end of the wreckage path, which was located about 1.5 miles from the departure end of LFT runway 22L.

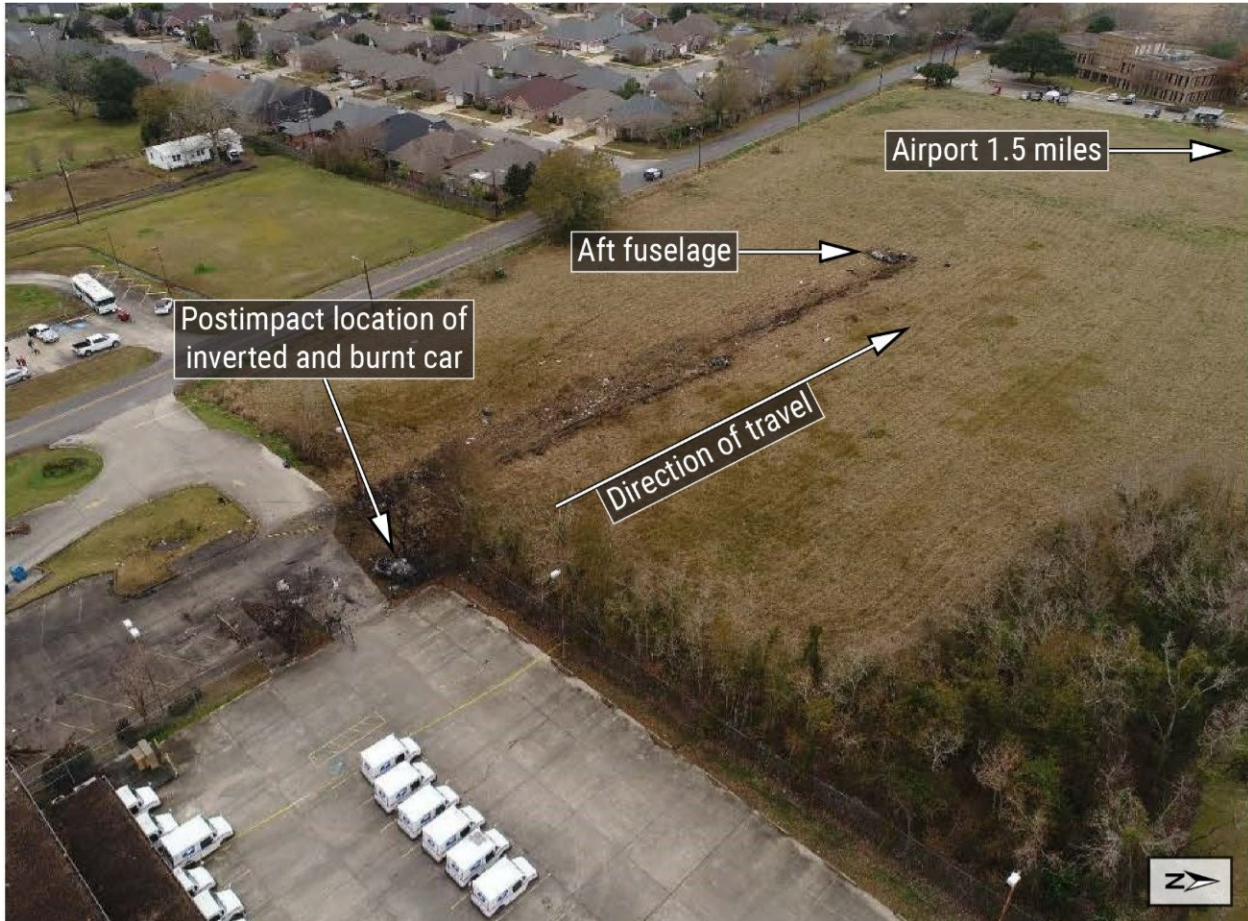
Figure 3. Wreckage path in field adjacent to post office.

Several windows in the front of the post office building were shattered during the impact sequence, and broken glass was found on the sidewalk in front of the building. A car, which was originally parked in front of the building, was found at the edge of the parking lot (see figure 3). The car was inverted, the roof of the car was crushed, and all the windows were broken. The car exhibited heat and fire damage.

The fuselage was fragmented and exhibited exposure to heat and fire. The right wing, outboard left wing, left and right engines, left and right elevator controls, rudder, instrument panel, and forward cabin separated from the fuselage. The cabin seats and the fragmented remains of the instrument panel were distributed throughout the debris field. The throttle quadrant was located on the right side of the debris field near the inverted and burnt car. The throttle quadrant was impact and fire damaged and did not provide any reliable throttle positions or indications.
