## FIRE INVESTIGATION REPORT

FIRE INVESTIGATION  
201 E. Franklin St.  
Richmond VA 23219

Incident # C202204301

On February 11, 2022, at approximately 2235 hours (Shift # C) I was advised of a fire involving a structure located at 2300 Hanover Ave Richmond. Instructions were provided to respond to that location and conduct an origin and cause investigation involving a three-story, Educational Facility structure. At the time of the assignment the following information was provided involving the circumstances of the fire. Fire units were on the scene of Fox Elementary School on a third alarm fire.

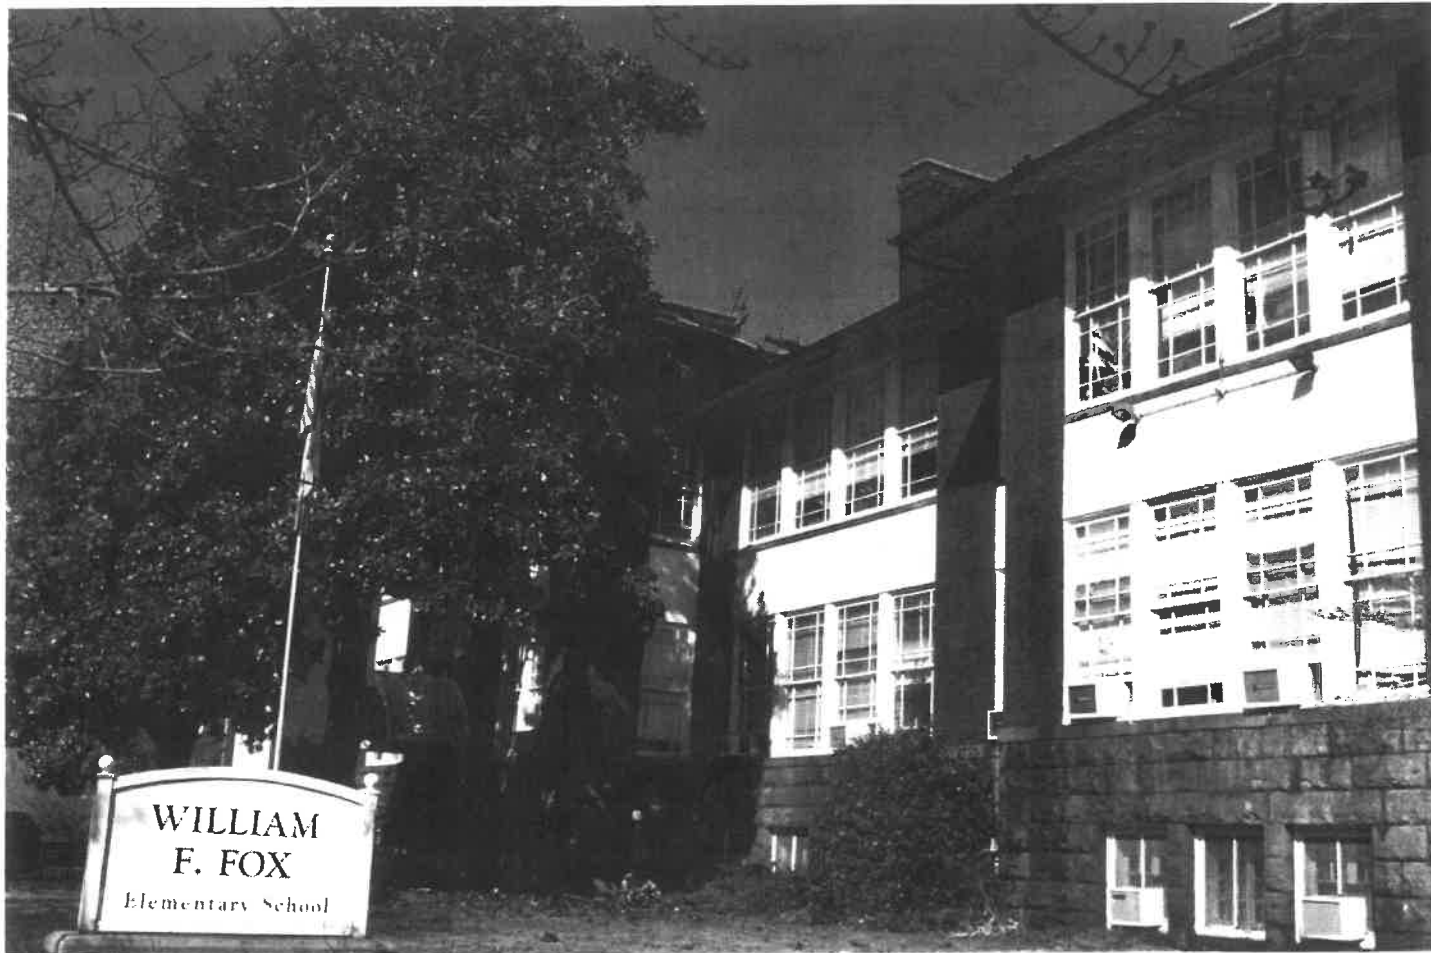
While examining the exterior of the structure I noticed obvious visible signs of extensive fire damage throughout the entire roof area of the structure. Numerous photographs of the structure were obtained to document the extent of damage to the structure.

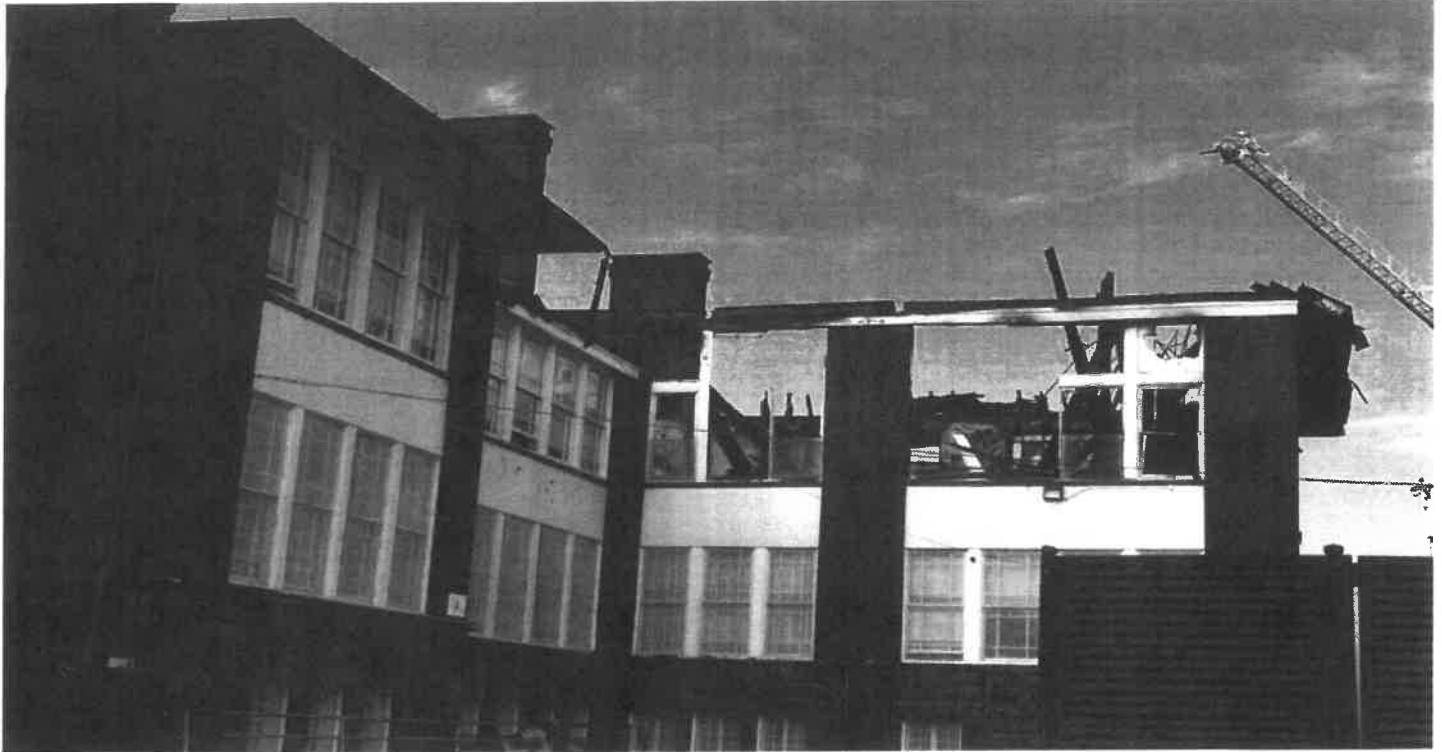
Examination of the structure's exterior roof areas revealed it had been constructed using composition type (asphalt shingles). Examination of the roof areas revealed fire and heat-related damage. These damages were the result of heat impingement from the interior areas.

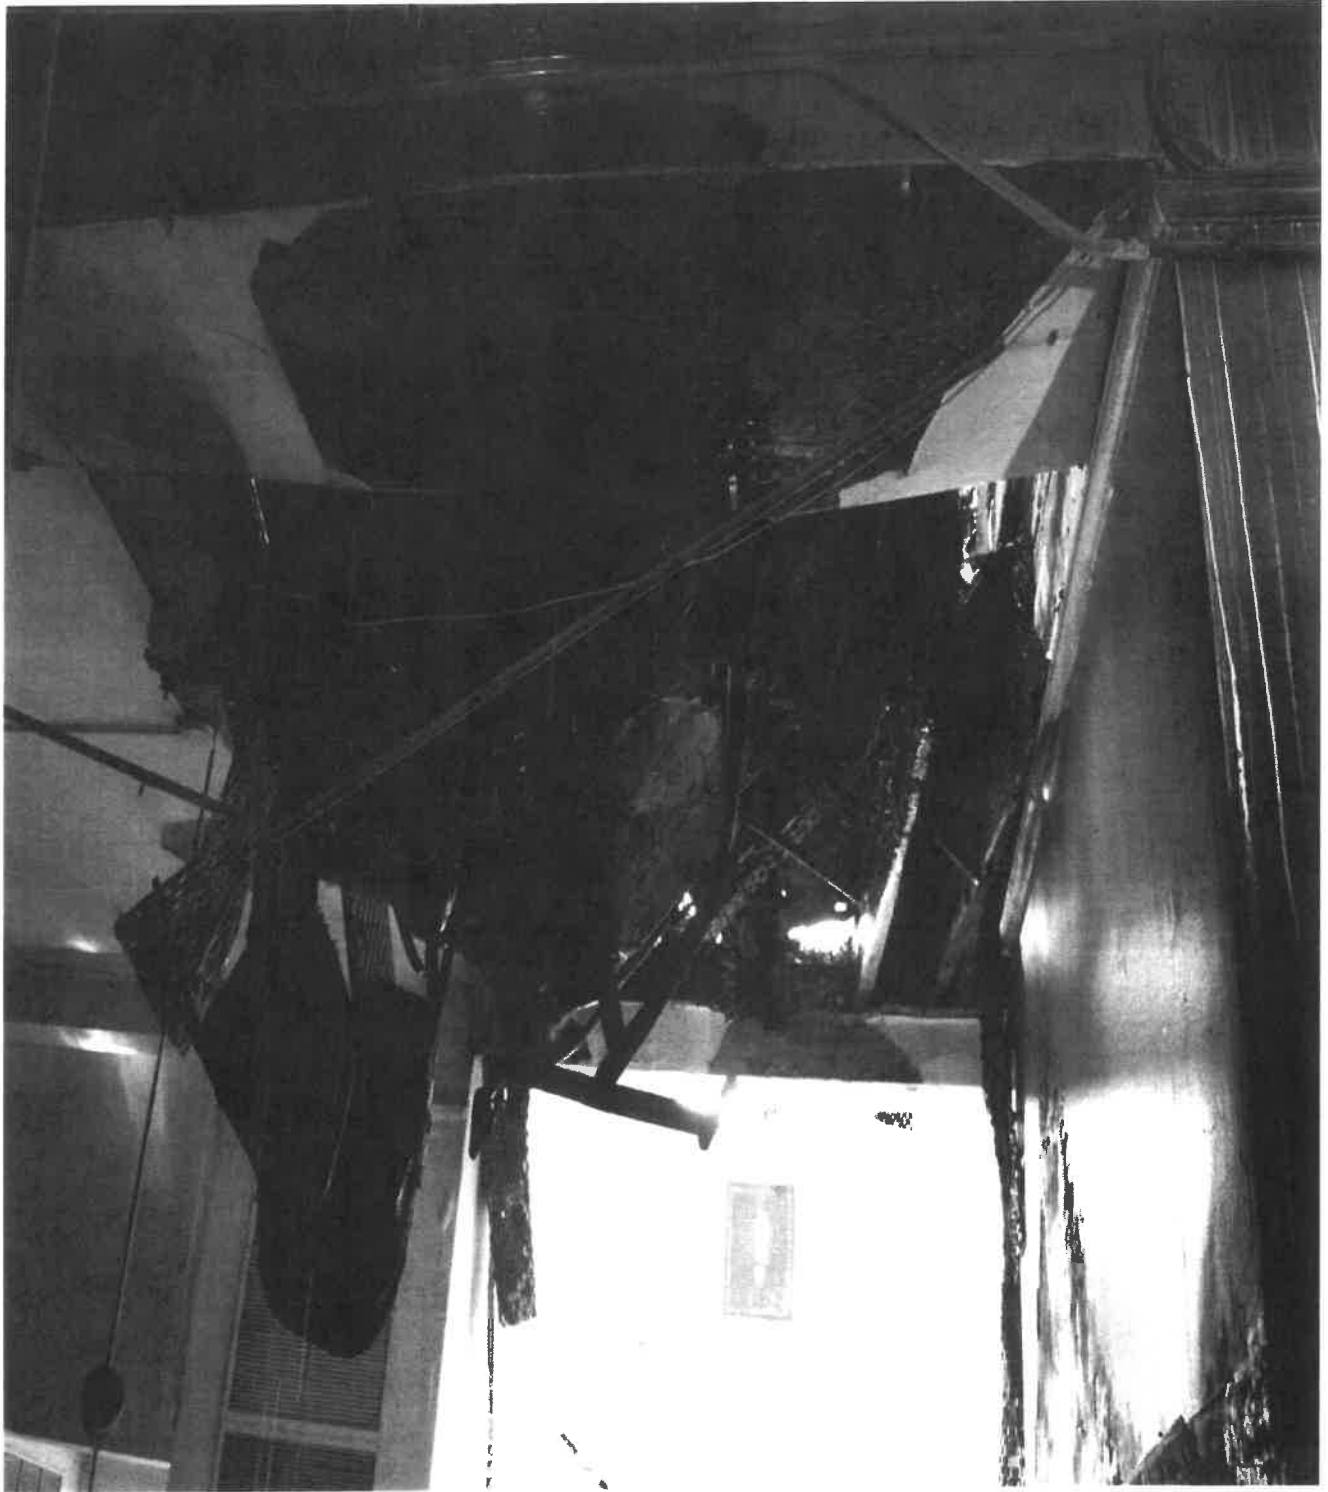
While examining the interior of the structure we started on the first floor from the entrance door located on the "B" side of the building. As I entered the structure on the floor I noticed the walls and hallway ceiling displayed signs of water damage as a result of fire department suppression efforts. There were also places within the hallway where the ceiling above was damaged as a result of water usage during suppression efforts. Photographs of this area were obtained for documentation purposes.

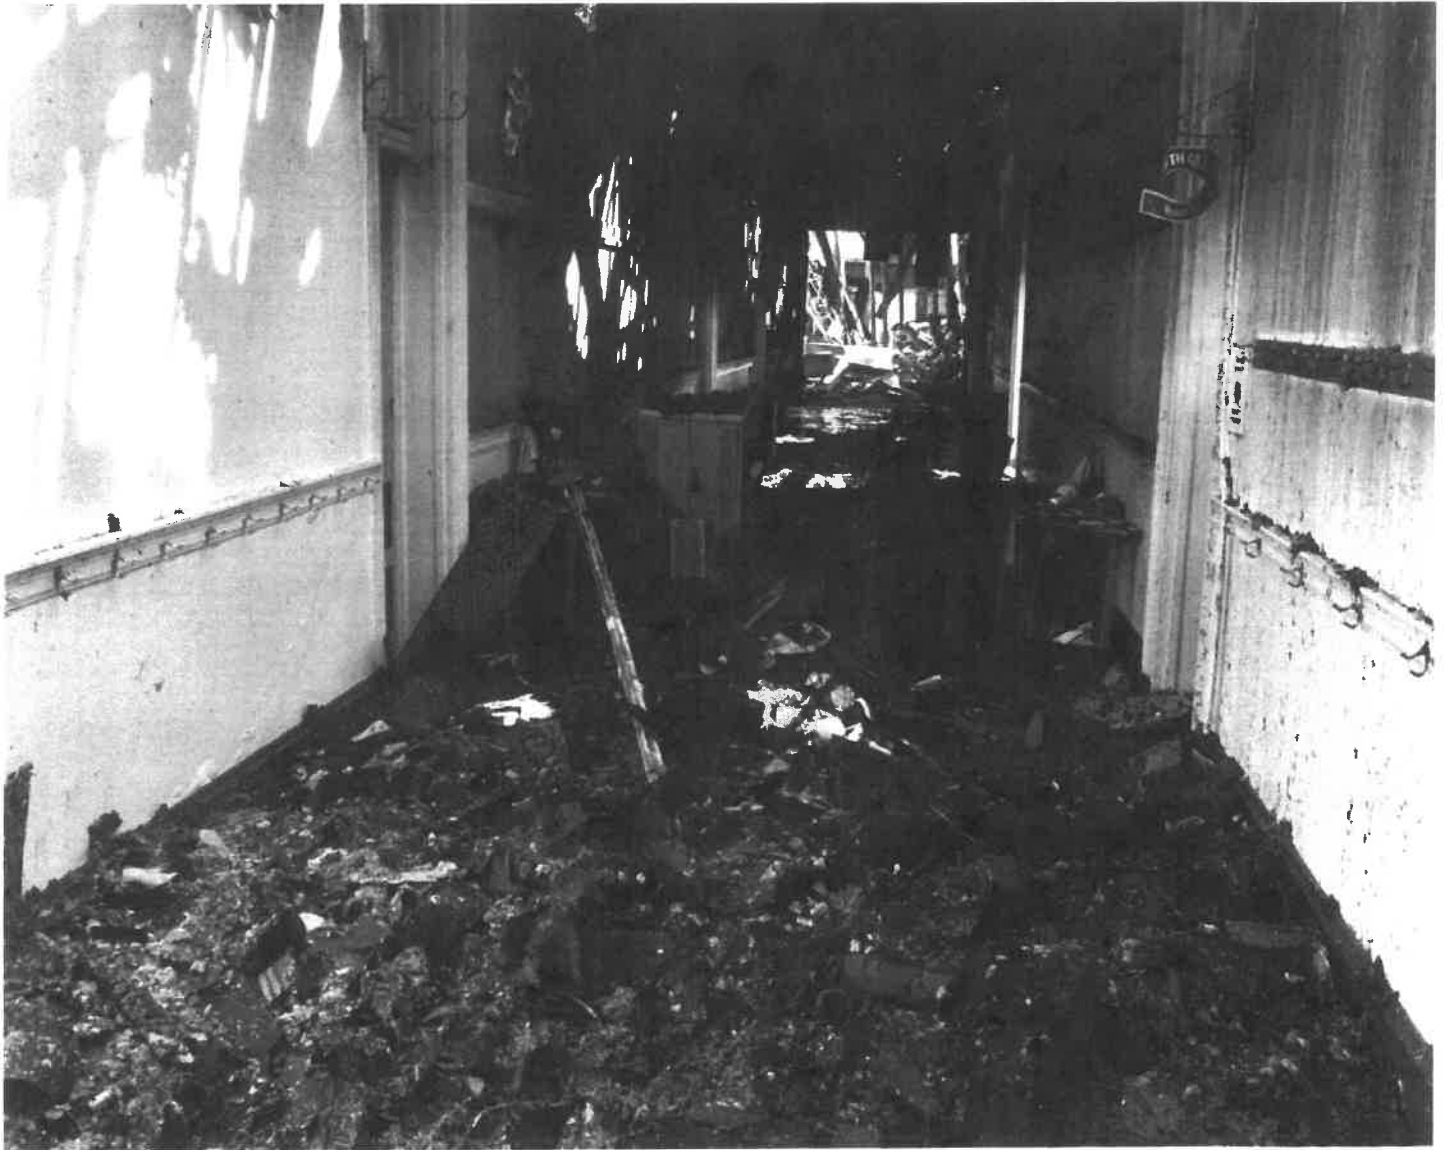
The examination then continued to the second floor of the structure starting on the "B" side of the building. While starting in this area of the structure I noticed the roof had been burned away on this side of the structure. The roof trusses were also burned, but the burn patterns indicated the fire was on the top side of the trusses. This was documented by photographs. There were large amounts of fire debris on the floor in the hallway and visible signs of smoke stains on the walls. The roof in this area of the structure had been burned completely away. There was a large pile of burnt debris located on the floor including shingles, insulation, and smaller pieces of wood that had fallen from the ceiling further ahead down the hallway. The roof trusses were still present but did present with signs of top-down burning on the majority of them. Each classroom presented with the same type of burn patterns on their respective ceiling trusses.

Each classroom was visually inspected for fire damage and then documented by photographs. [REDACTED] The fire damage observed on the second floor was deemed to be more significant than what was observed on the first floor. I continued documenting this area while moving towards the end of the hallway located at the opposite end of the building where the attic area was located which contained the classroom and auditorium that Mrs. Jacobs informed investigators of during the documented interview. Once I made it to this area of the second floor I noticed the fire damage appeared to be the most significant compared to the other areas of the structure. The charring on the remaining wood was heavier, and there were signs of incomplete combustion located in the classroom located next to this area. The roof in this area of the structure had collapsed onto the floor. This area could not be accessed due to safety concerns for the investigators.
