# FIRE INVESTIGATION ORIGIN & CAUSE REPORT

## Aspen Acres Wildfire

CO-Highway 165 Mile Marker 17, Rye, Colorado 81069

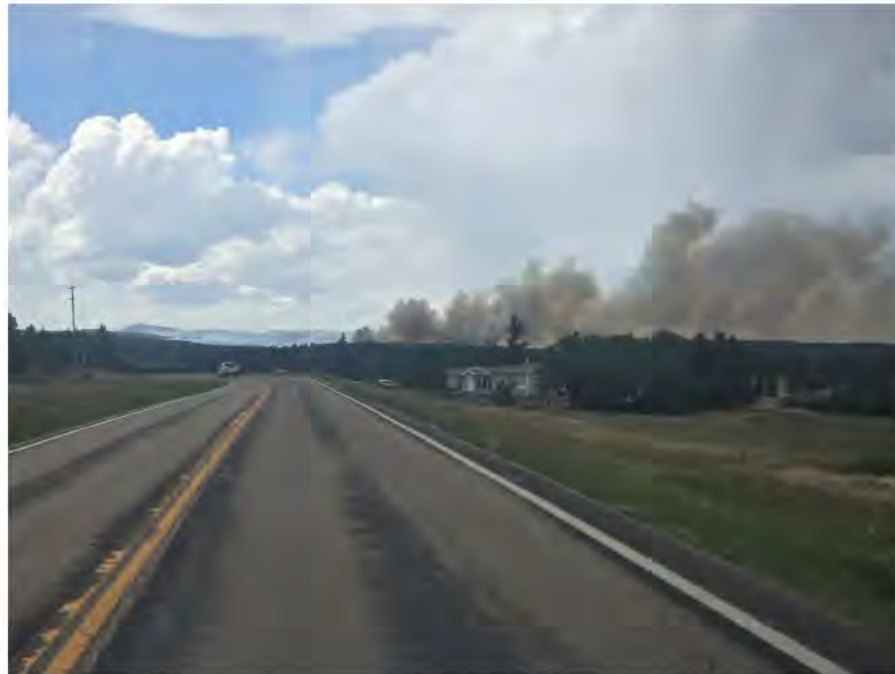
Aspen Acres Fire looking north from Rye, Colorado (20260630\_155755)

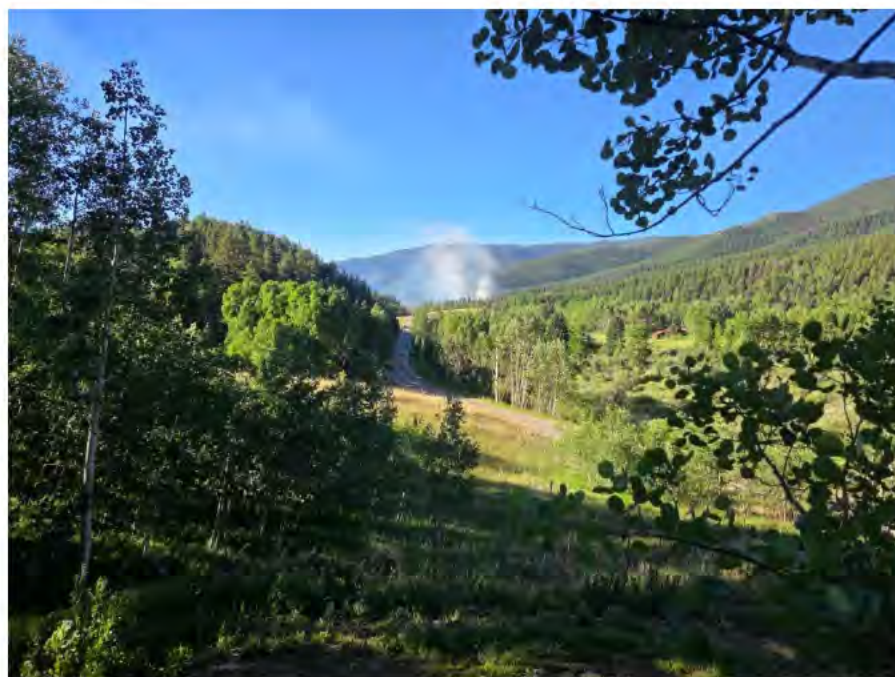
Picture taken by Guy Richter from his residence on Davis Drive, morning of June 29, 2026

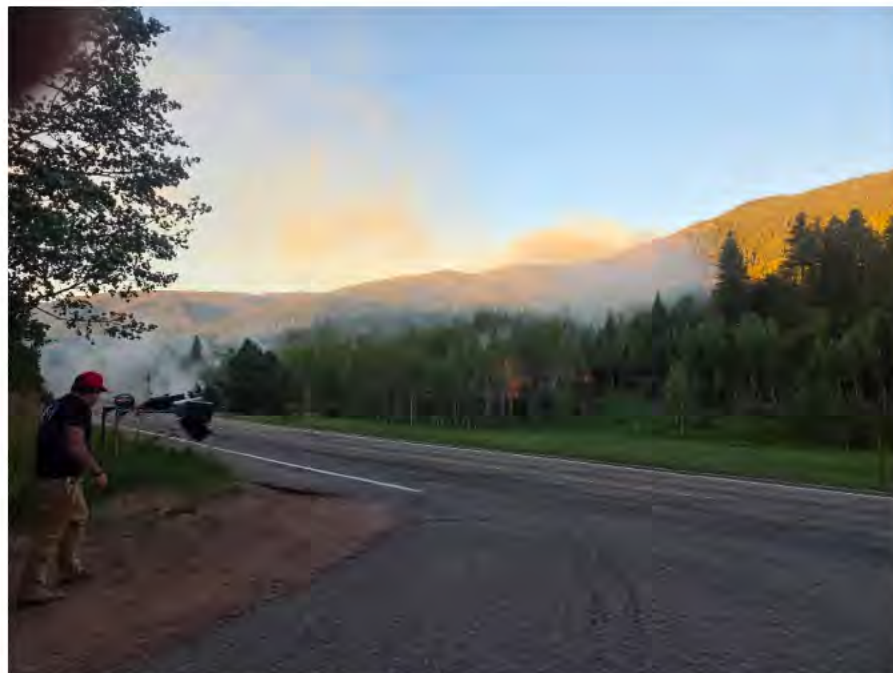
Picture taken by Guy Richter from CO-165 and Custer Drive, morning of June 29, 2026

7. When he got to the location, CO-165 and Custer Drive, he observed smoke and fire in the tree line along the powerlines.
8. He described the fire was primarily in that area at that time.
9. While he was there, several other residents showed up.
10. While he was at that location, the fire was spotted from the west side of CO-165 to the east side of CO-165.
11. He stated Guy Richter had sent him two photographs of the initial fire.

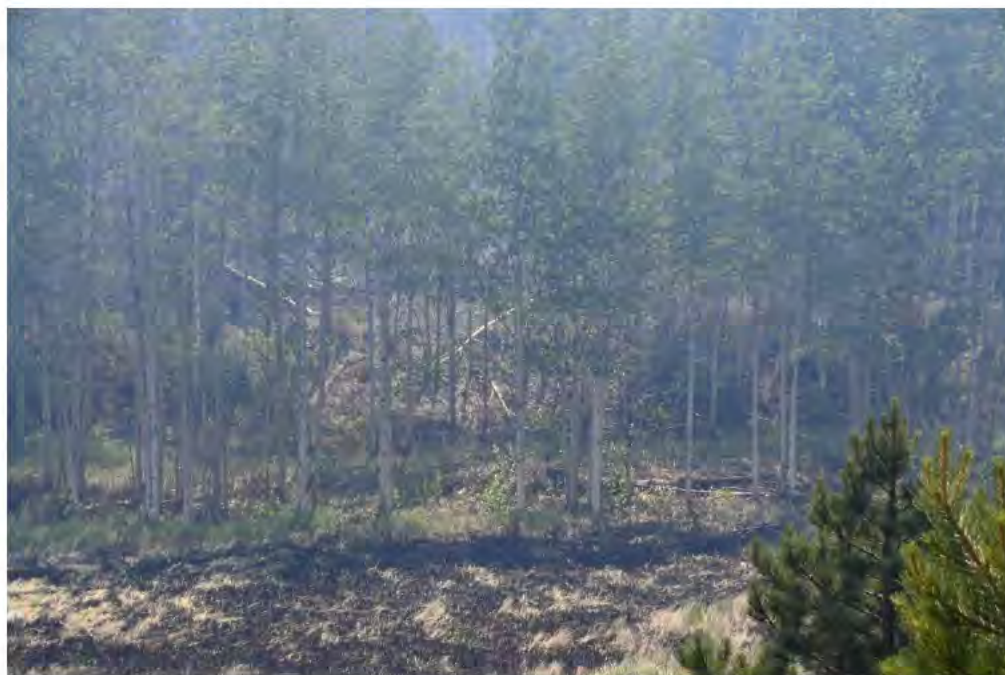
The fuel package at the general origin area<sup>10</sup> for Aspen Acres Fire consists of an area that was estimated at one acre. The area was covered with grass, brush, trees, and various forms of vegetation.

General area of origin (JMD\_4222)

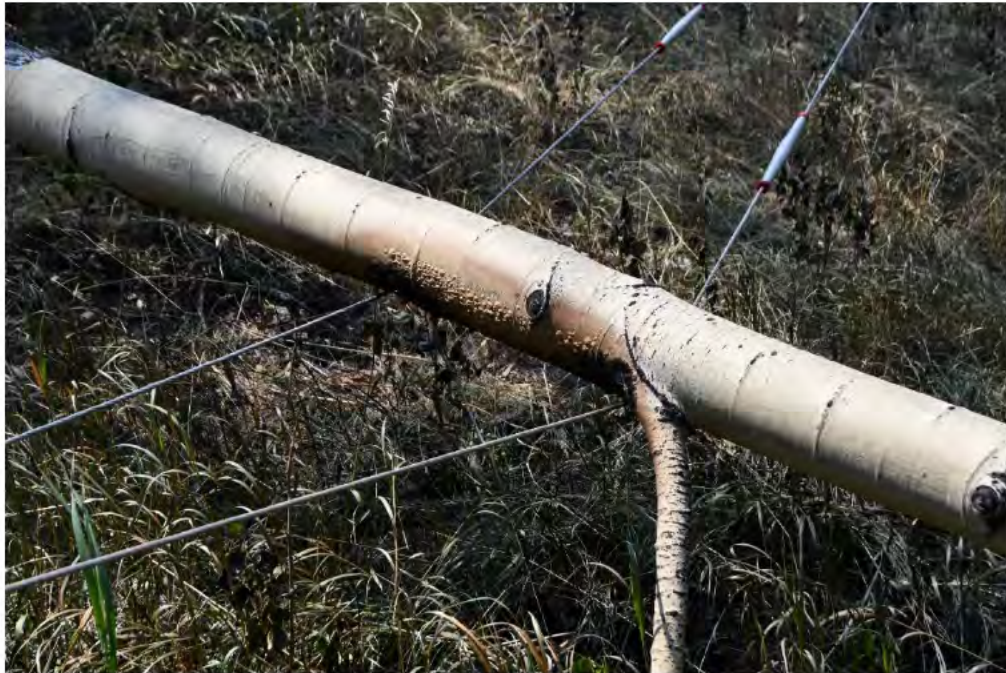
The specific origin area<sup>11</sup> was located at a point where the section of aspen tree had contacted the conductors, stretching the conductors to approximately three feet above the ground. The aspen tree trunk was in contact with both the hot and neutral conductor. The aspen tree had mass loss to the bark with charring and burn marks where the tree was in contact with the conductors. The conductors had arcing, melting and charring.

Specific origin area (JMD\_4236)

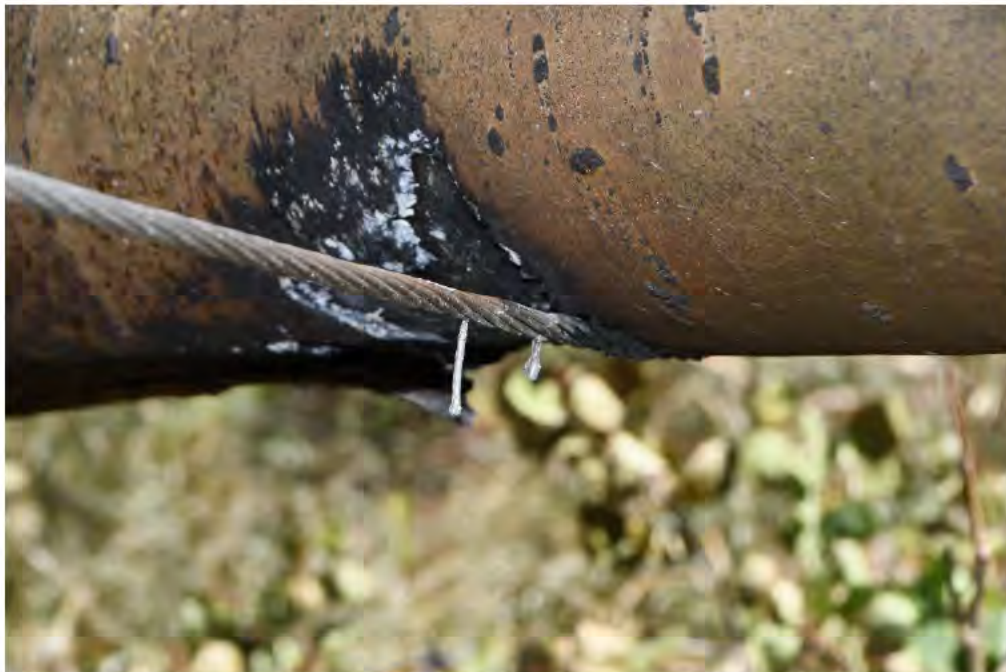
Melting of conductors (JMD\_4251)

During a wind event, an aspen tree had fallen and contacted energized conductors. The energized conductors provided sufficient heat energy to elevate the tree bark and nearby vegetation to a point that would support combustion. Melted aluminum was observed under the area where the conductor contacted the tree presented with melting. The melted aluminum dripping from the conductor should also be considered as contributing to the ignition of the fire. The ignition scenario is coupled with contributing elements associated with the falling of the tree during high winds. A wind verification report was generated as an addendum and is attached to this report.

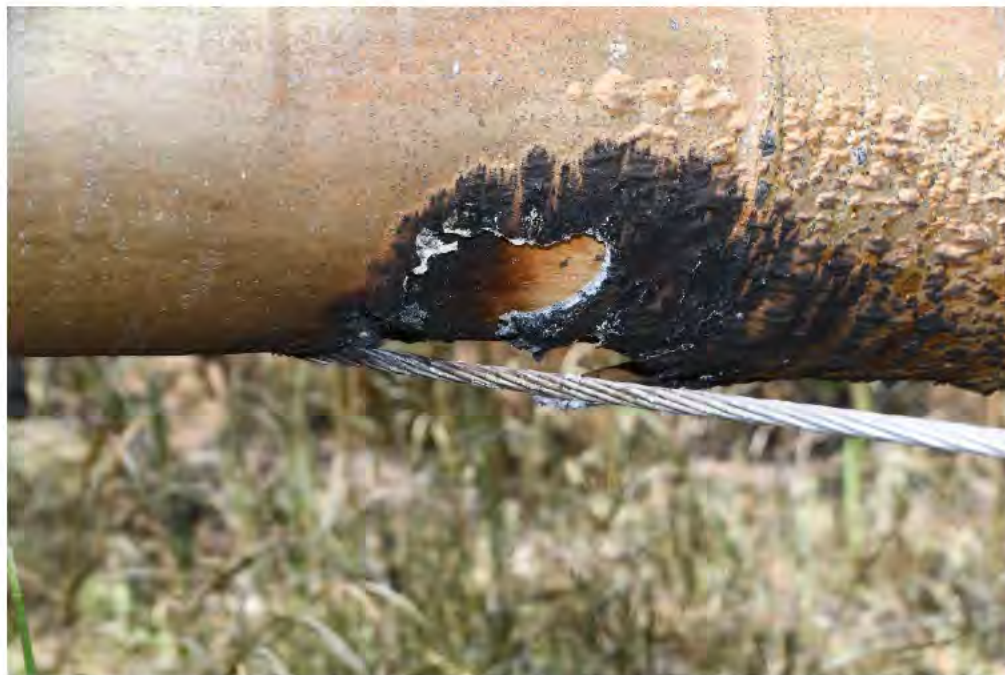
Arcing on conductors (JMD\_4254)

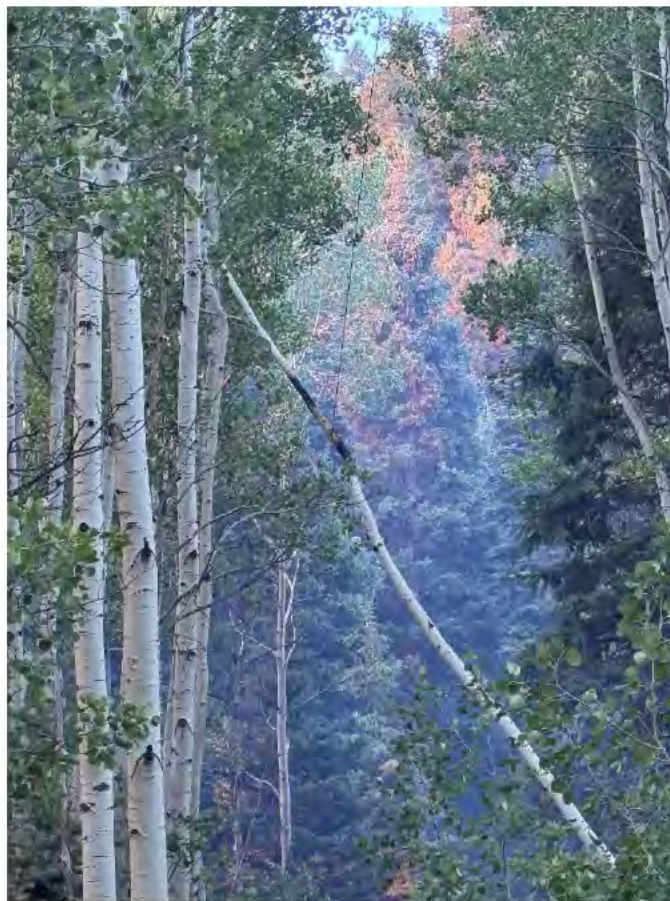
I evaluated the movement, intensity, fire pattern indicators on the surrounding trees that presented with charring at the base. I observed the absence of consumed fuels related to grasses, pine needles, ground foliage, aspen and pine trees. Additionally, this is supported by an eyewitness account during the fire and is reinforced by photography provided by Mr. Richter. The combined overall fire patterns, and eyewitness account do not support the Silvercliffe area as a location where fire originated.

Photograph provide by Guy Richter, taken by "Turtle." From Silvercliffe Drive

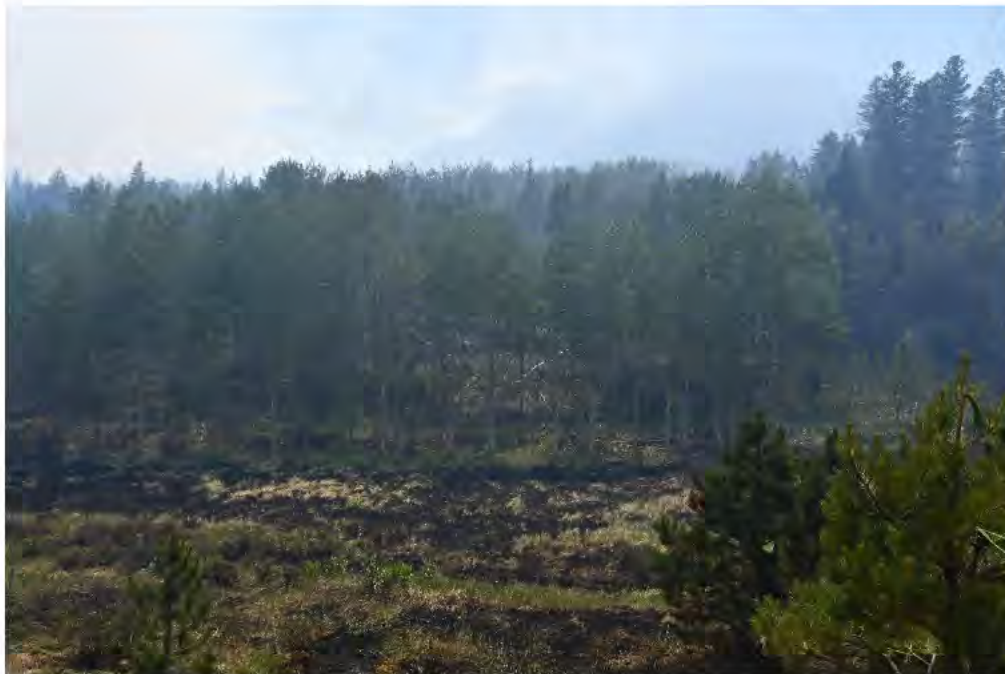
The general origin area for the Aspen Acres Fire is approximately 200 feet west of CO-Highway 165 at mile marker 17 and southwest of the intersection of CO-Highway 165 and Custer Drive. (38°00'29.52" N / 105°03'59.88" W)

General area of origin (JMD\_4214)

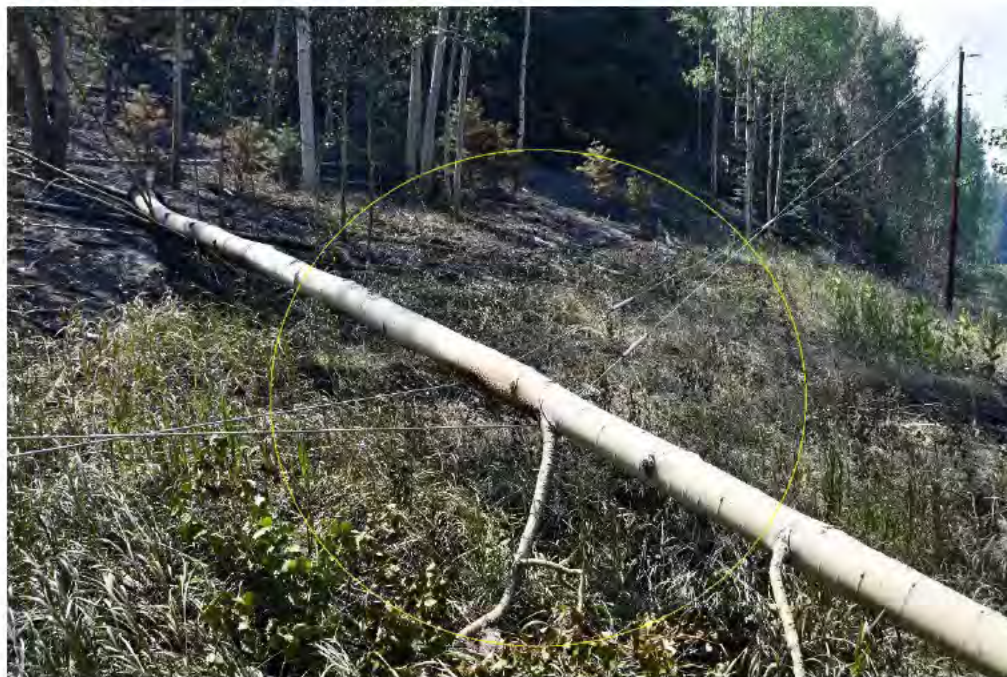
The specific origin area is where the fallen tree contacted the overhead energized conductors. The subject conductors extend parallel to CO-Highway 165. (38°00'28.9" N / 105°04'00.7" W)

Specific area of origin (JMD\_4233)

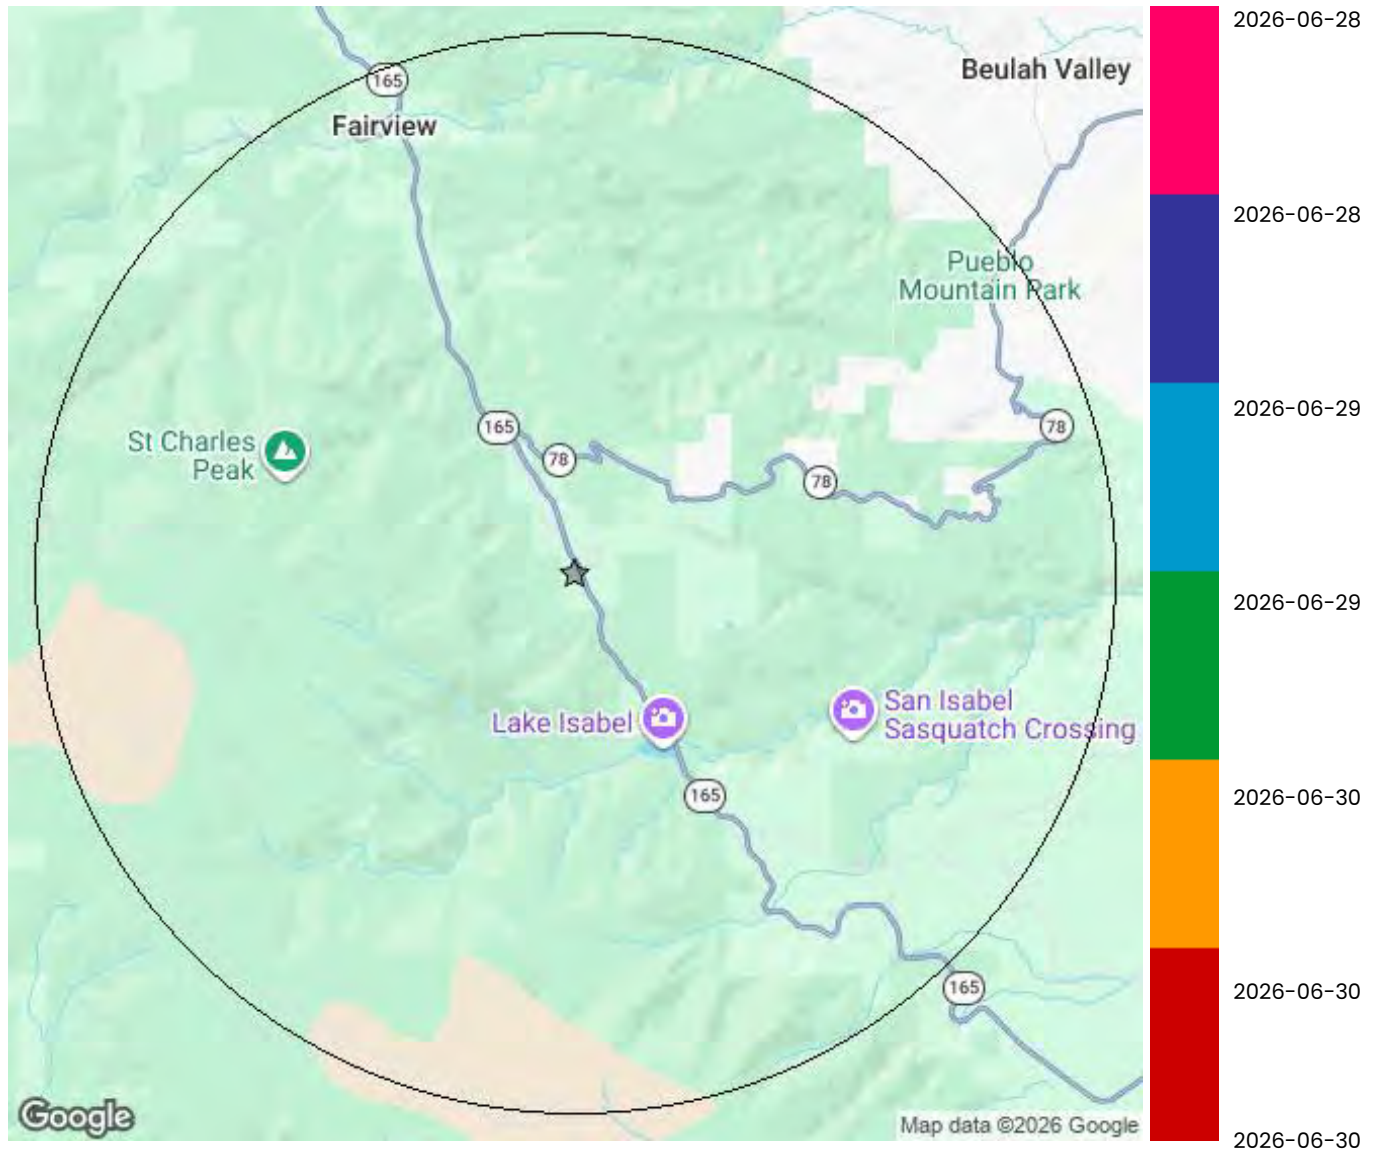
## Confidence Ellipses For Lightning Strokes

Lightning Confidence Ellipse Map indicates with 99% certainty that the recorded lightning event contacted the ground within the bounds of the ellipse.
