# Aviation Investigation Preliminary Report

| <b>Location:</b> | Lincoln, MT | <b>Accident Number:</b> | WPR26FA032 |
| <b>Date &amp; Time:</b> | October 24, 2025, 21:15 Local | <b>Registration:</b> | N740TS |
| <b>Aircraft:</b> | CIRRUS DESIGN CORP SR22T | <b>Injuries:</b> | 1 Fatal |

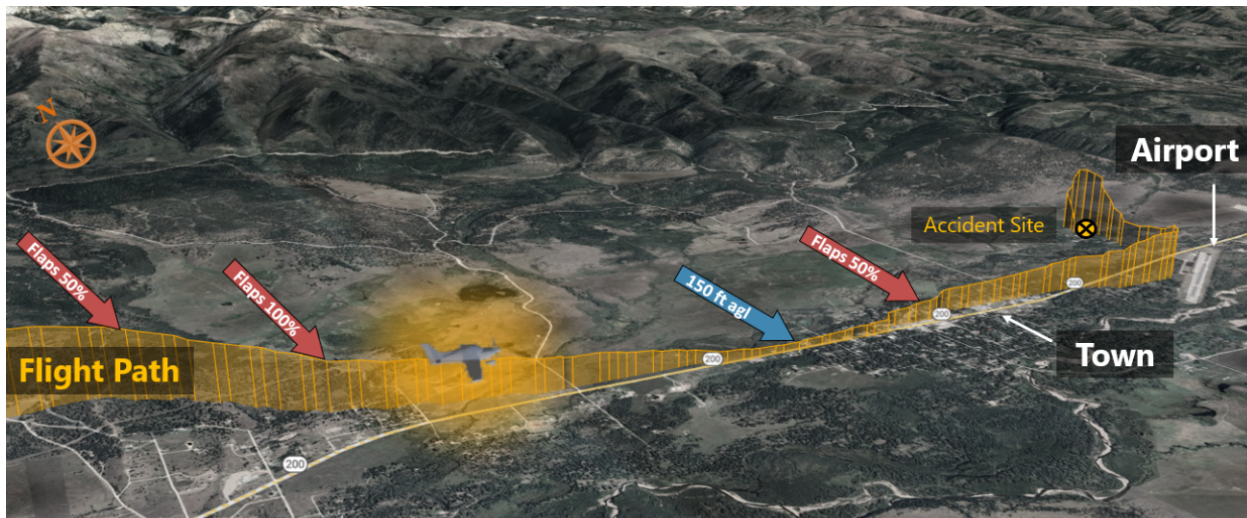
As the airplane descended into the valley at 2112:39, about 1,150 ft above ground level (agl), the pilot lowered the flaps to 50%. The airplane continued to descend and full flaps (100%) were selected 17 seconds later. The airplane aligned with Highway 200, an east-west oriented road that passed directly through the town of Lincoln. (See Figure 1). While flying over the

highway, descending to an altitude of 150 ft agl, the indicated airspeed was between 77 and 87 kts. The airplane then began a gradual climb and the flaps were retracted to 50%, where they remained until impact.

Figure 1: Accident flight path as the airplane approached the destination airport

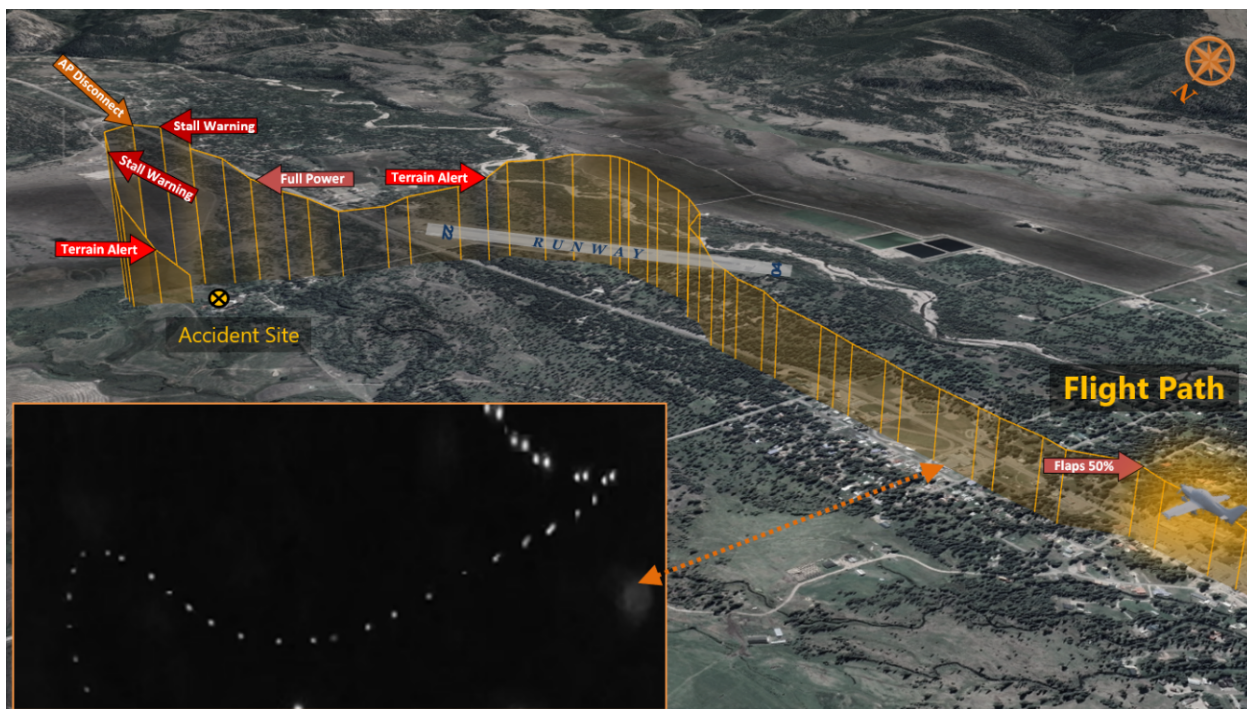
The airplane passed over the town and momentarily crossed to the south side of the highway as it maneuvered toward the airport. (See Figure 2). At 2114:43 the airplane was north of the runway near midfield about 1,030 ft agl. The airplane then made a left turn near the airport's beacon light and was on a north heading while descending to 575 ft agl. During the descent, at 2114:51 the Terrain Awareness and Warning System (TAWS) activated. The airplane began to climb 5 seconds later and full power was added about 2115:00. A steep left bank was initiated and the stall warning activated at 2115:06 as the airspeed slowed to 50 kts. Immediately thereafter, the autopilot and yaw damper disconnected. A second stall warning activated and the left-bank continued to steepen while the airplane descended rapidly to the accident site. During the 7 second descent, there was another TAWS alert at which time the engine remained at full power.

Figure 2: The last portion of the accident flight (inset showing a composite of the video footage)

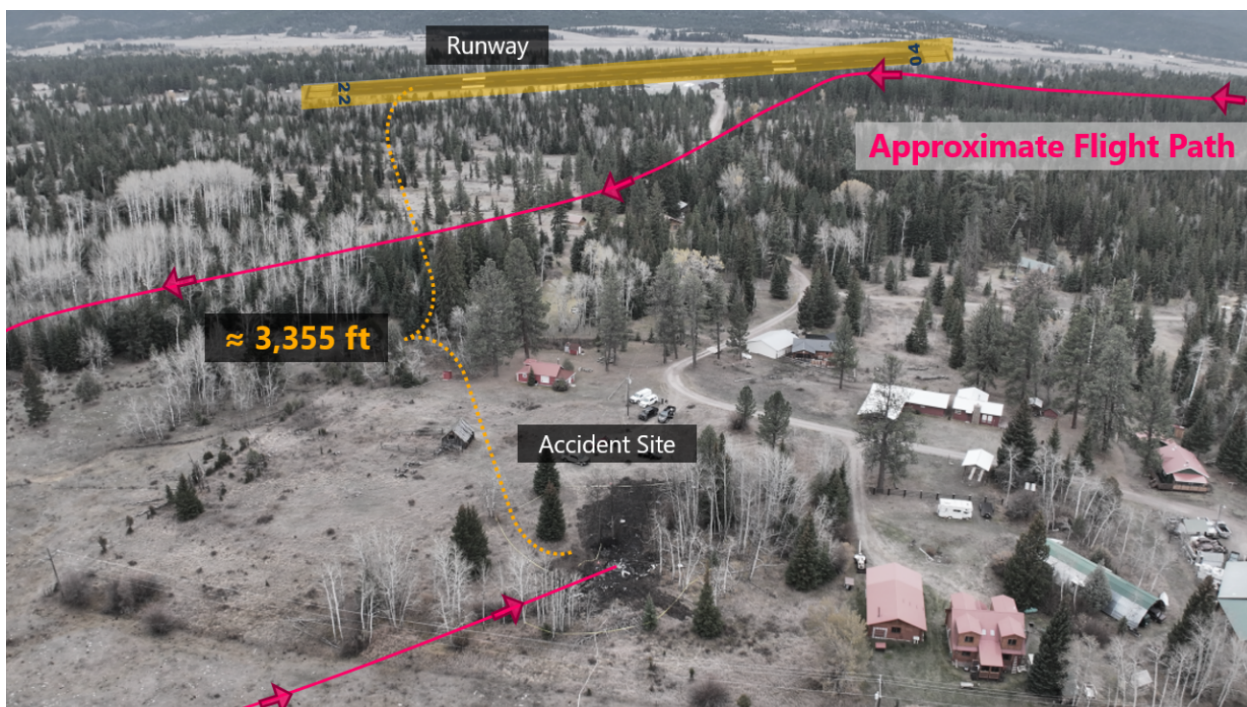
The accident site was located on flat terrain in a sparsely populated neighborhood north of the airport. The terrain consisted of soft dirt and there were numerous trees immediately surrounding the accident site. The accident site was at an elevation of about 4,600 ft and located 3,355 ft from the runway surface. (See Figure 3).

Figure 3: Aerial view of the accident site in reference to the runway

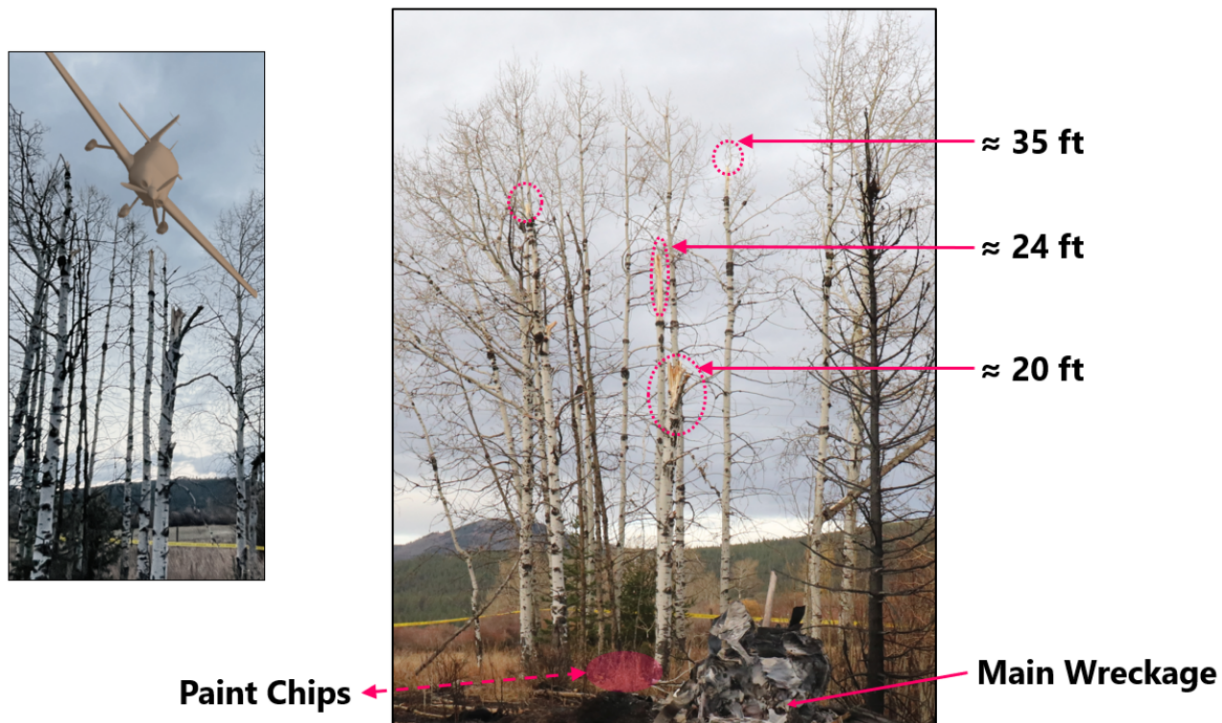
At the beginning of the debris field was a group of mature aspen trees that were severed at various heights. (See Figure 4). The damage and cuts in the trees were progressively lower in height moving toward the main wreckage. Close examination of the cuts in the trees revealed that paint chips were embedded in the fresh tree cuts. The left-wing spar was separated about six feet inboard from the wingtip; there was composite material similar in appearance to the spar found embedded in a downed tree top. The left main landing gear was separated from its respective gearbox, consistent with impact with a tree.

Figure 4: Trees at the start of the debris field with a model showing possible impact angle matching the damage
