# Aviation Investigation Preliminary Report

<b>Location:</b>	Flagstaff, AZ	<b>Accident Number:</b>	WPR26FA098
<b>Date &amp; Time:</b>	February 4, 2026, 22:16 Local	<b>Registration:</b>	N56AZ
<b>Aircraft:</b>	Bell 407	<b>Injuries:</b>	2 Fatal
<b>Flight Conducted Under:</b>	Public aircraft

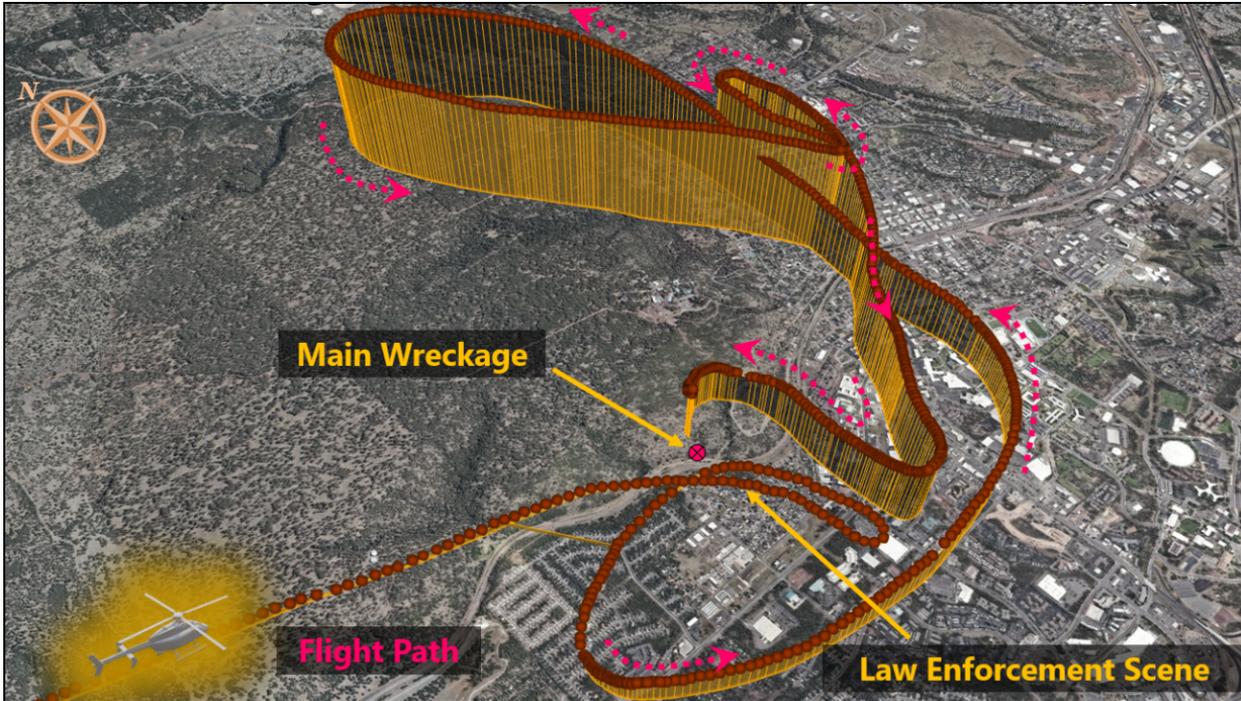
Figure 1: The helicopter's flight path

A review of Federal Aviation Administration (FAA) automatic dependent surveillance-broadcast (ADS-B) data, video and audio recorded by law enforcement body cameras, and residents' security cameras revealed that the helicopter departed Kingman about 2110 and continued east toward Flagstaff. As the helicopter approached the city, the TFO was in communication with law enforcement personnel on the ground, who provided the approximate location of the active shooter. At 2205, the helicopter descended and operated between about 300 and 500 ft agl while performing a 360° turn over the neighborhood in the vicinity of the active shooter. The helicopter then performed a gradual climbing left turn south of the active shooter before establishing a northerly course. (See figure 1.)

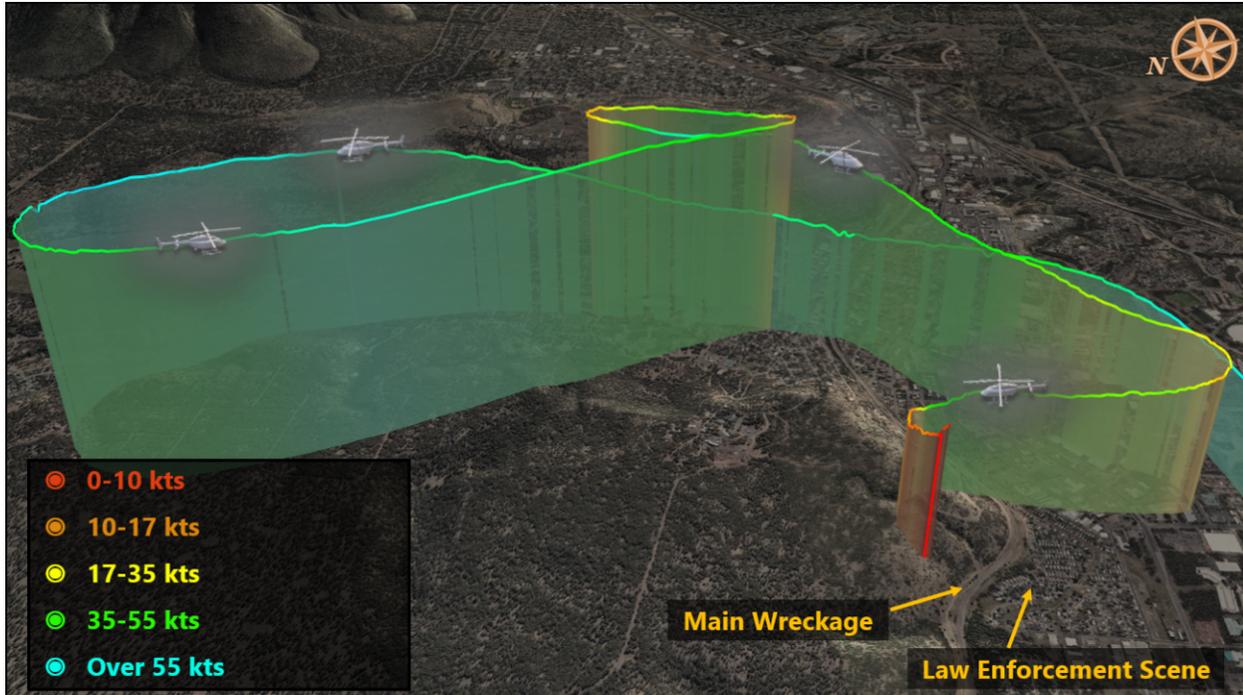
Figure 2: Flight path displaying airspeeds

The pilot maneuvered the helicopter in a gradual climb north of the neighborhood and performed a left 180° turn to return south to allow clearance for a helicopter that was inbound to Flagstaff Medical Center. At 2212:10, while the helicopter was at an altitude of 9,950 ft msl, it passed in the vicinity of the hospital-bound helicopter, which was on a northeast route at about 7,200 ft msl. Thereafter, the helicopter performed a left 360° turn and returned south toward the law-enforcement scene while descending to 8,900 ft msl (see figure 2 below). The helicopter then turned north and performed a gradual climbing left turn, consistent with aligning for an out-of-ground-effect (OGE) hover to maintain visual contact of the suspect. At 2216:24, the TFO initiated a radio transmission to law enforcement personnel on the ground; there were no indications of any abnormalities during the communication.

A review of available video showed the helicopter in a slow climb and then at 2216:43, the helicopter began a rapid rotation to the right. The rotation coincided with an unidentified verbal sound on the radio, followed by two loud banging sounds from the helicopter. The helicopter then descended rapidly toward terrain and at 2216:51, the TFO stated over the radio, “we’re going down.” During the descent, the helicopter’s spotlight was observed in video to flash periodically, consistent with continued aircraft rotation.

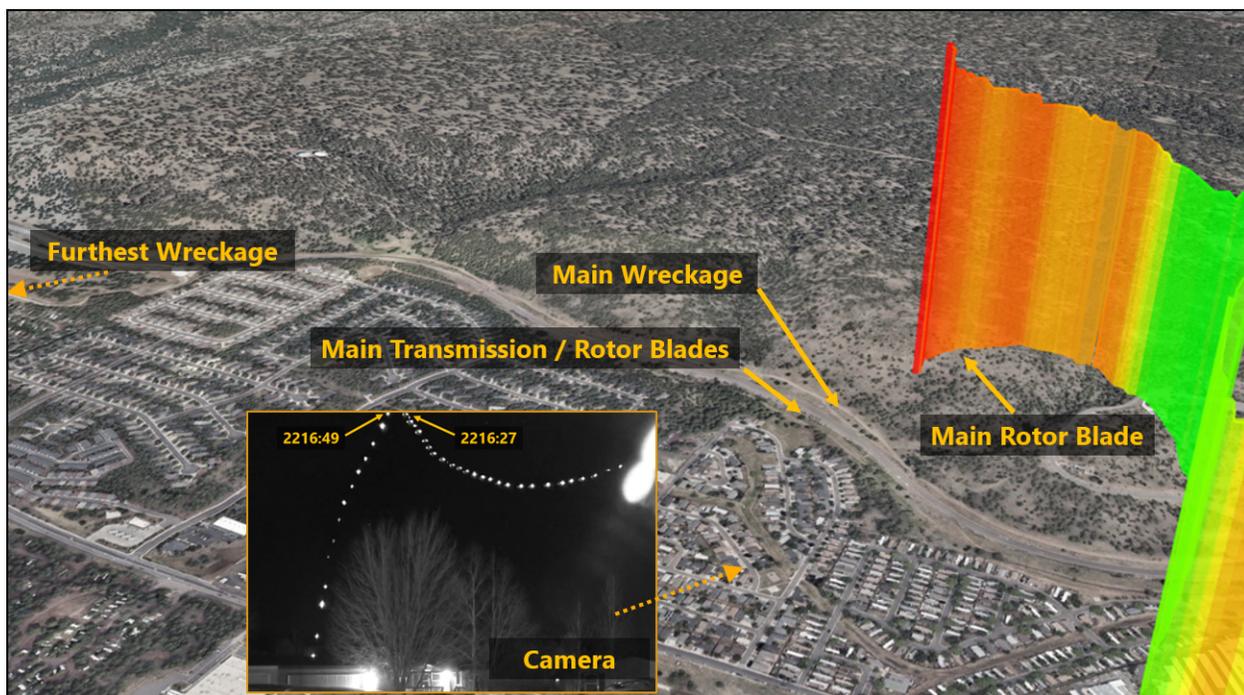
Figure 3: Picture of wreckage distribution and composite of video

The main wreckage was located on a flat dirt access road about 3 nm north of the Flagstaff Airport at an elevation of 7,010 ft msl. A section of the Burlington Northern Santa Fe (BNSF) railway tracks was located about 100 ft south of the main wreckage. The wreckage was distributed along a debris path on a median bearing of 250°; the most distant wreckage was located more than 6,150 ft from the main wreckage.

The main rotor hub, main rotor transmission, and three main rotor blades were located about 165 ft south of the main wreckage (see figure 3 below). The fourth main rotor blade, blade grip, and portion of its respective yoke were not located with the main rotor assembly; it was separated from the rotor hub and located 650 ft northeast of the main wreckage. All blades were lightly coated with an orange/yellow oil film.
