# National Transportation Safety Board Aviation Accident Preliminary Report

Location:	Las Vegas, NV	Accident Number:	WPR20FA013
Date & Time:	10/23/2019, 1553 PDT	Registration:	N225JM
Aircraft:	Robinson R44	Injuries:	2 Fatal
Flight Conducted Under:	Part 91: General Aviation - Personal

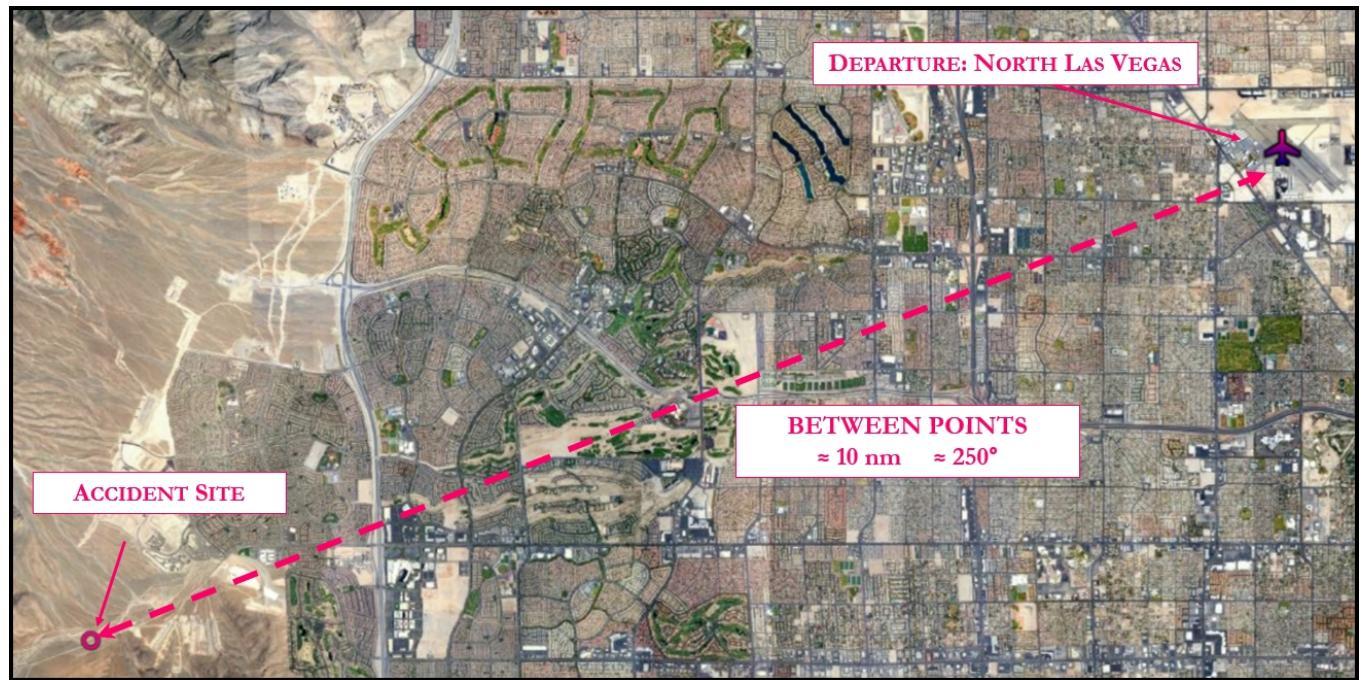
The pilot had called Airworks, the fixed based operator (FBO) that rented the helicopter, in the early afternoon on the day of the accident. During the call he asked the office personnel if the R-44 was available to rent that afternoon. One of the schedulers responded that the helicopter was undergoing maintenance and the pilot stated that he would stop by the office anyway to check if the maintenance was done and put money on his account. The pilot and passenger arrived about 10 minutes later. The pilot asked why the helicopter was in maintenance and the office personnel told him that an earlier flight was canceled because that pilot had found sediment in the fuel tanks. The accident pilot stated that he was happy to wait and about 20 minutes later, the certified flight instructor (CFI) that had canceled that earlier flight called stating that the maintenance was done and the helicopter was ready to fly. The pilot and passenger planned to take an hour flight since they needed to return the helicopter back to the FBO for a tour scheduled at 1900 (see picture 01 to see location of accident site in reference to departure airport).

Picture 01: Airport to Accident Site

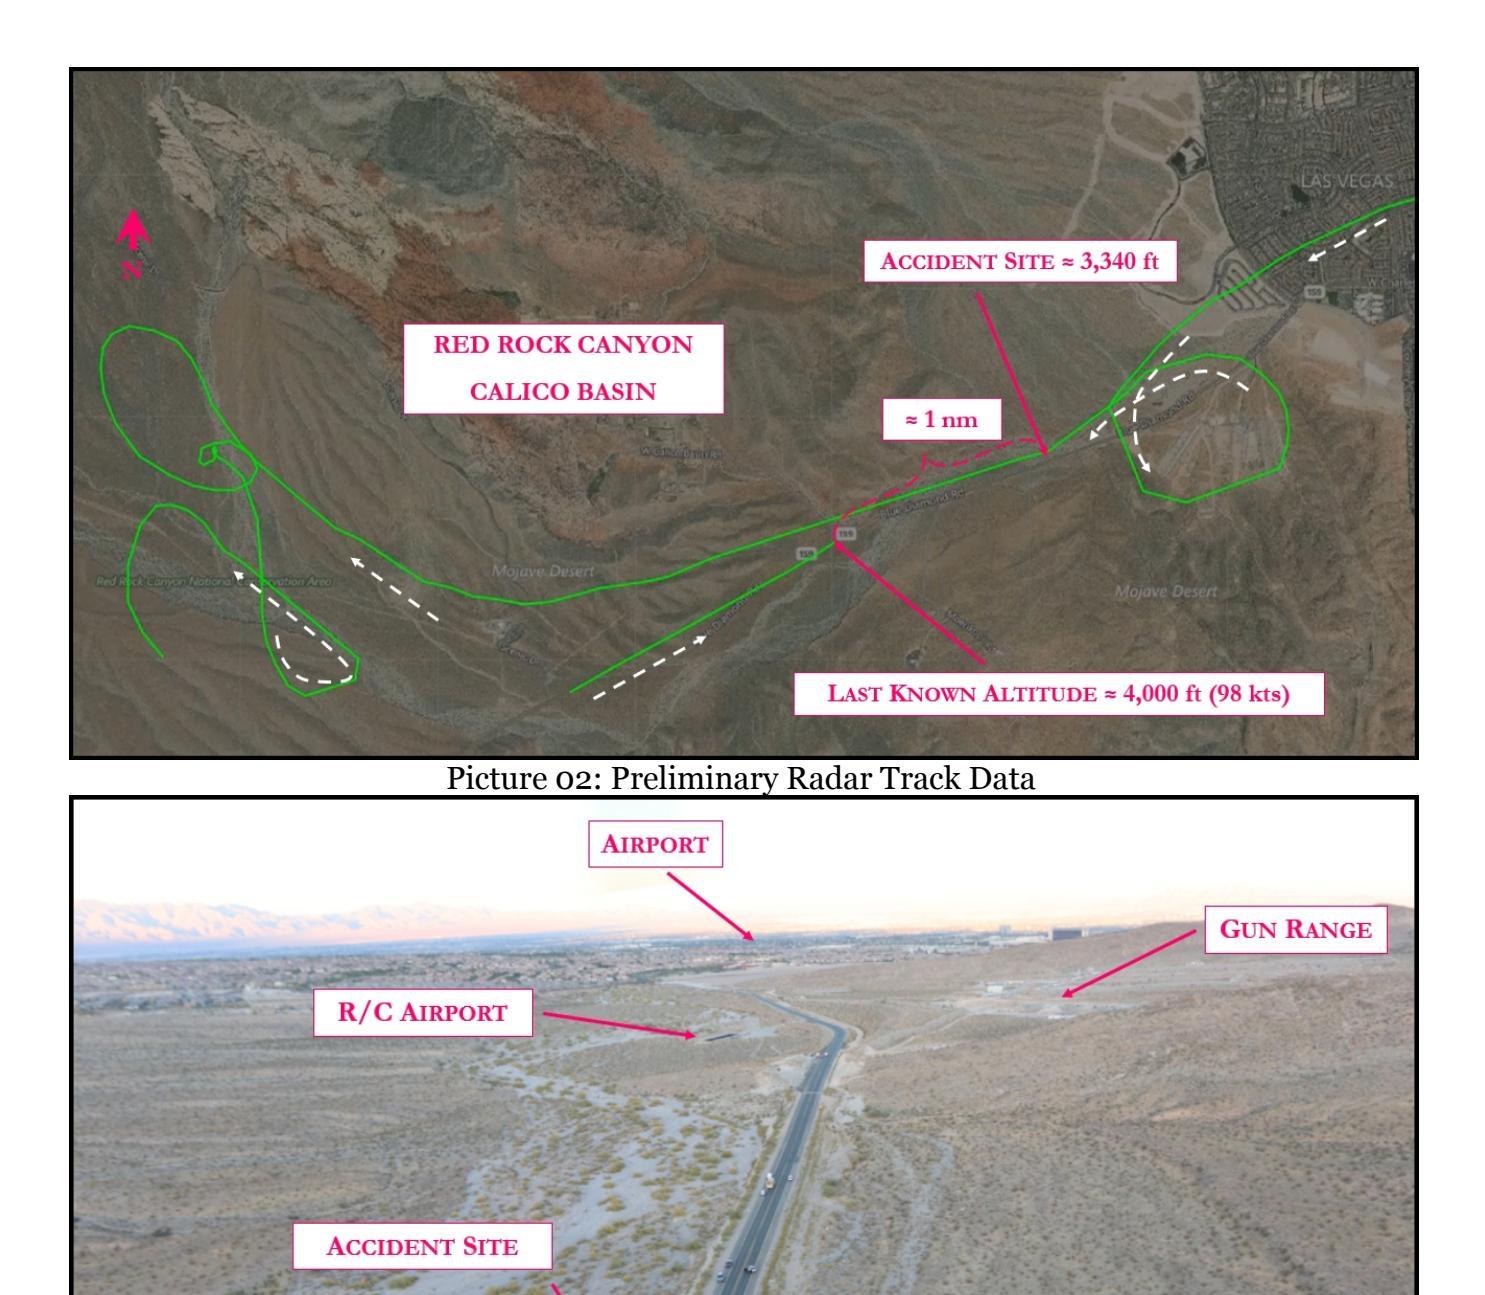
Picture 03: Wreckage in Relation to Surrounding Landmarks

The accident site was located in the desert terrain about 10 nm from the departure airport on a bearing of 250°. The wreckage was found distributed in a ravine over a 200 foot distance on a median magnetic bearing of about 070° (see picture 03). The ravine and debris field ran parallel to the road and was located about 4-5 feet below the pavement. The first identified area of impact was an approximate 5 inch line (oriented parallel to the road) of scraping and maroon-colored paint transfer across a rock and orange torque strip buried in the dirt before the rock. Adjacent to that line was another parallel line of paint transfer that was red in color. The orientation and colors were consistent with the tail rotor guard (candy-cane: white and red) and tailskid (maroon with orange torque stripe) making contact first indicative of a nose-high attitude (see picture 04).

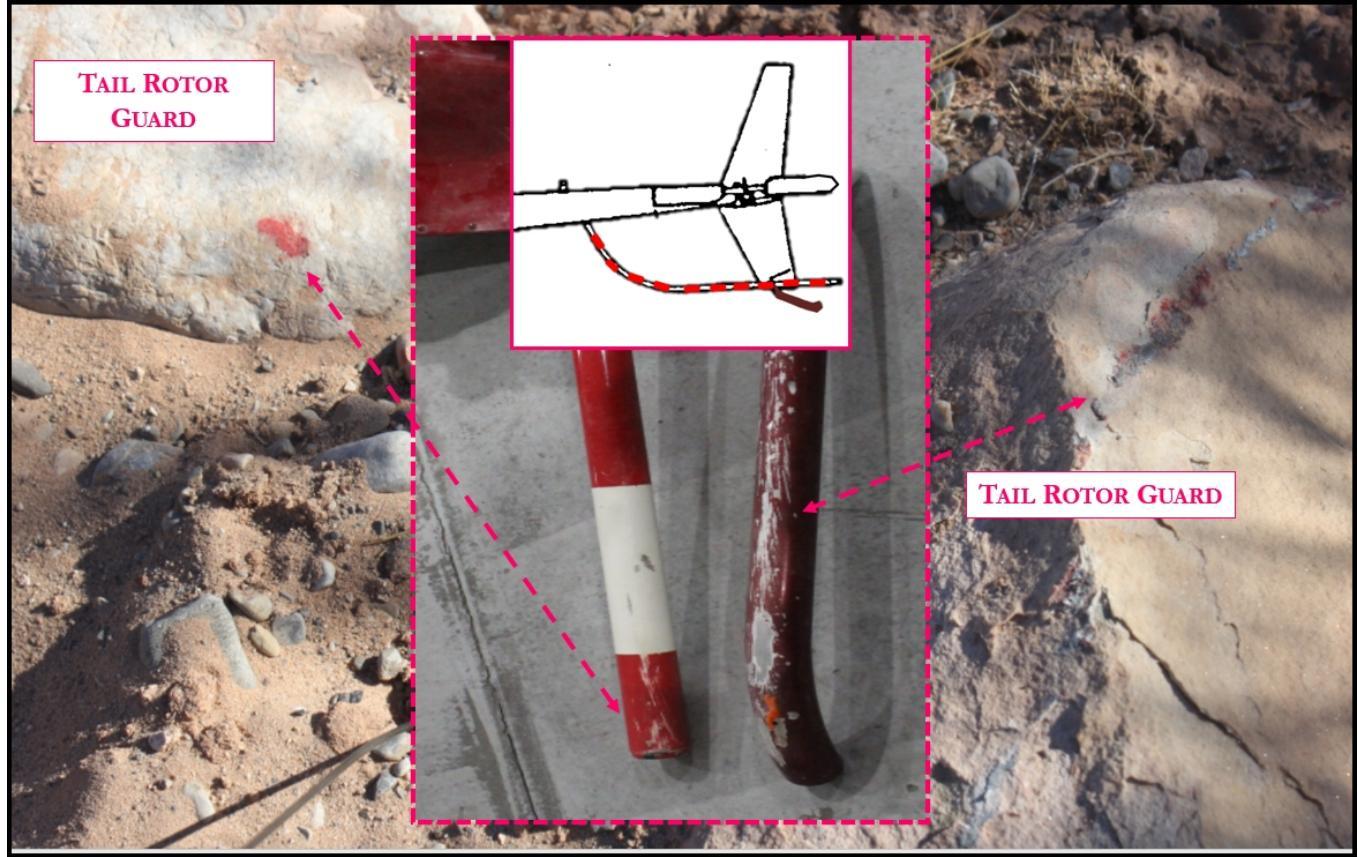
Picture 04: First Identified Point of Impact

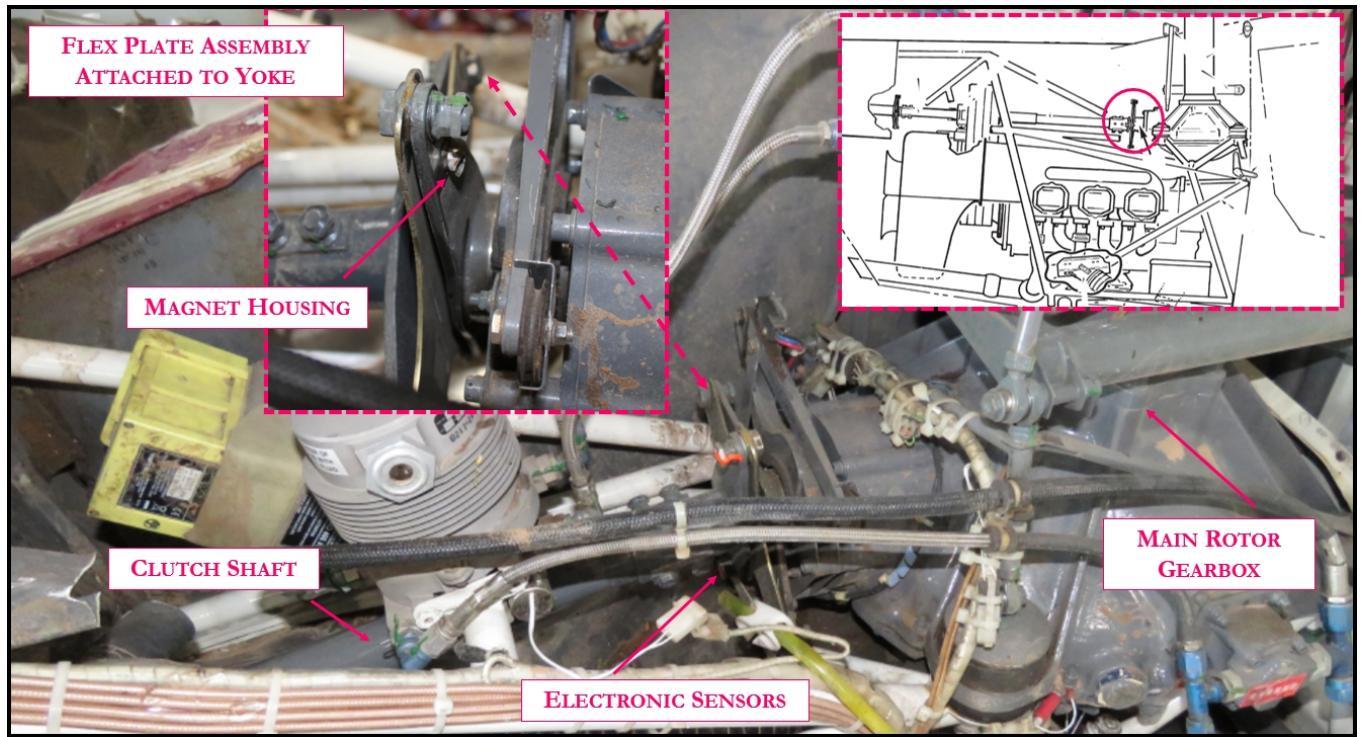
The helicopter was equipped with a rotor dual tachometer and the signal to the cockpit was provided by two magnets at the main gearbox drive yoke that pass by electronic Hall Effect devices (see picture 05). A Robinson representative reported that with only one magnet in place, the main rotor tachometer rpm would indicate about 50% of the actual rotor rpm. The post-accident examination revealed that one magnet was separated from the yoke assembly; the magnet was located on the fuselage frame near the firewall.

Picture 05: Rotor Tachometer System

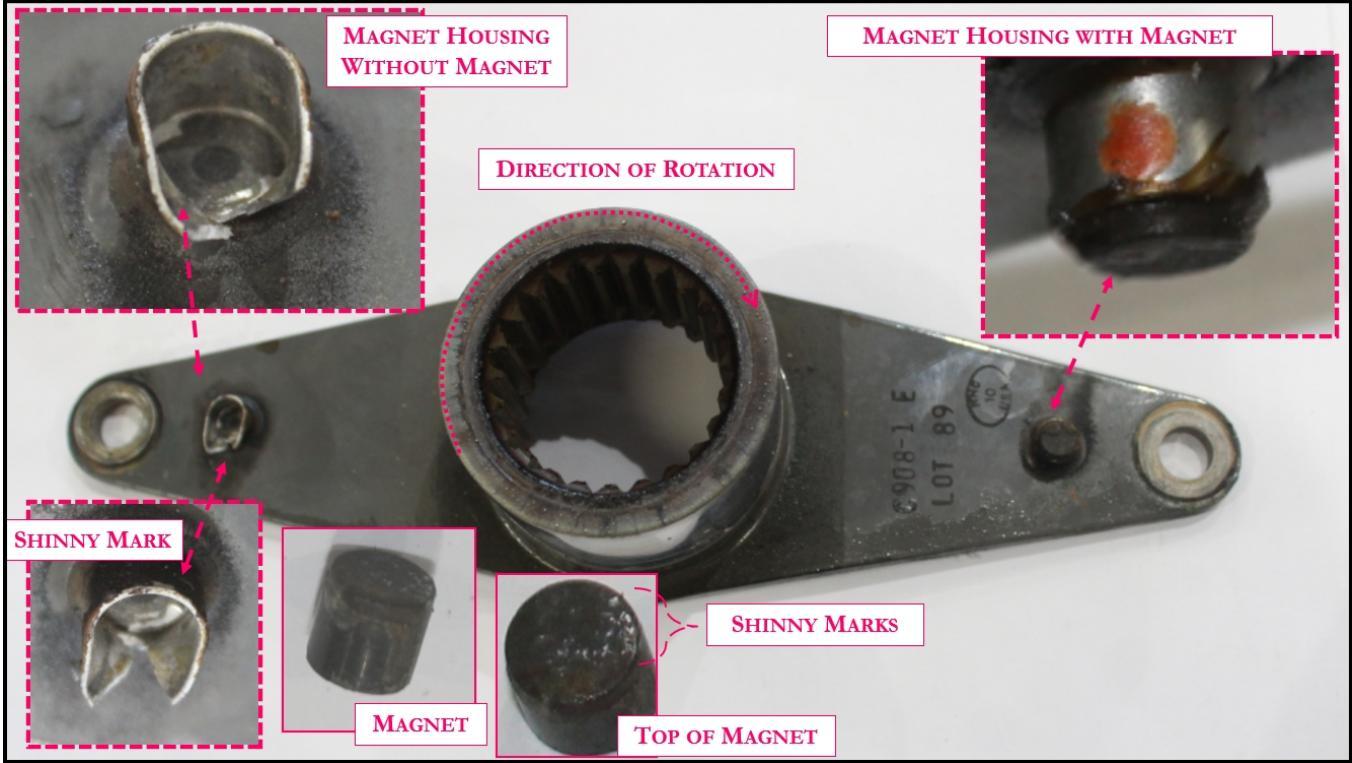
The magnet housing was shinny at the top of one side (the direction of rotation) consistent with contact of the magnet against a sender. The other magnet assembly remained secured to the yoke assembly. Both the housings showed a color consistent with a dark residue and a yellow/orange mark was on both housings and senders (see picture 06). The yoke assembly was not damaged.

There was evidence of slight damage to both senders, consistent with the magnet assembly separation.

Picture 06: Yoke Assembly

A Robinson Helicopter Company representative reported there have been instances of a magnet separating from a magnet assembly which prompted issuance of Service Bulletin (SB) 86, which required an adhesive be applied between the magnet and the magnet housing and a yellow dot placed on the magnet housing.
