Re: Claim under the Arizona Tort Claims Act

Claimants: Rolf Ziemann & Christine Wood,
Wrongful death beneficiaries of Elaine Herzberg
Date of Accident: March 18, 2018
Location of Accident: Mill Avenue, Tempe, AZ
Sum Certain Demand: Rolf Ziemann: \$5,000,000
Christine Wood: \$5,000,000

PRELIMINARY REPORT

HWY18MH010

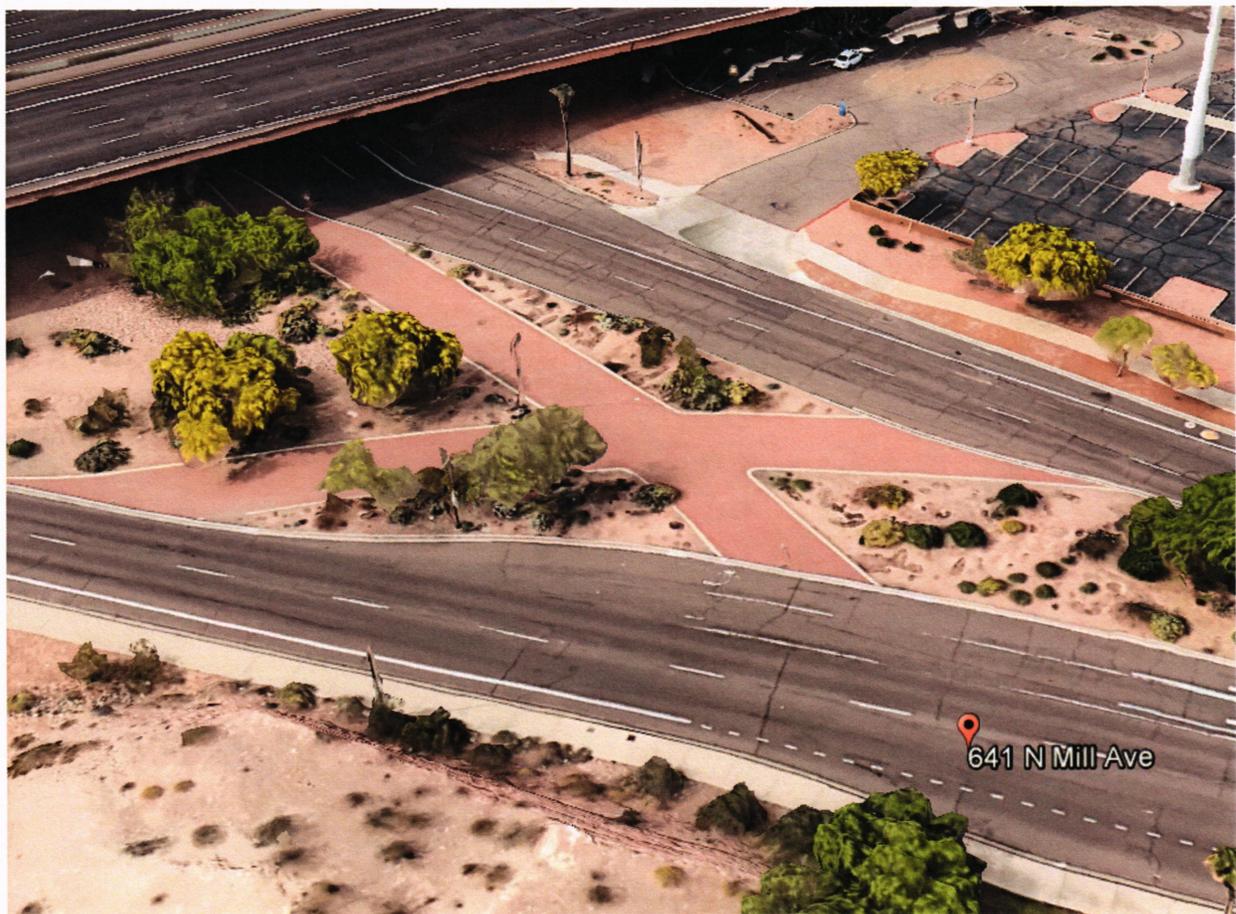
The median at the accident site has a brick pathway cutting through the desert landscaping that is clearly designed to accommodate people to cross at the site of the accident:

The City of Tempe created the hazardous condition of a dangerous walkway. Then they failed to (1) provide a crosswalk; (2) properly light the area so drivers could see pedestrians using the walkway; and (3) provide any other modifications that would have permitted safe crossing.

The City of Tempe knew or should have known that pedestrians would use the break in the median to cross the street. As such, the City of Tempe failed to exercise reasonable care to make the passage safe for pedestrians. As a result of this negligence, Elaine Herzberg suffered fatal injuries.

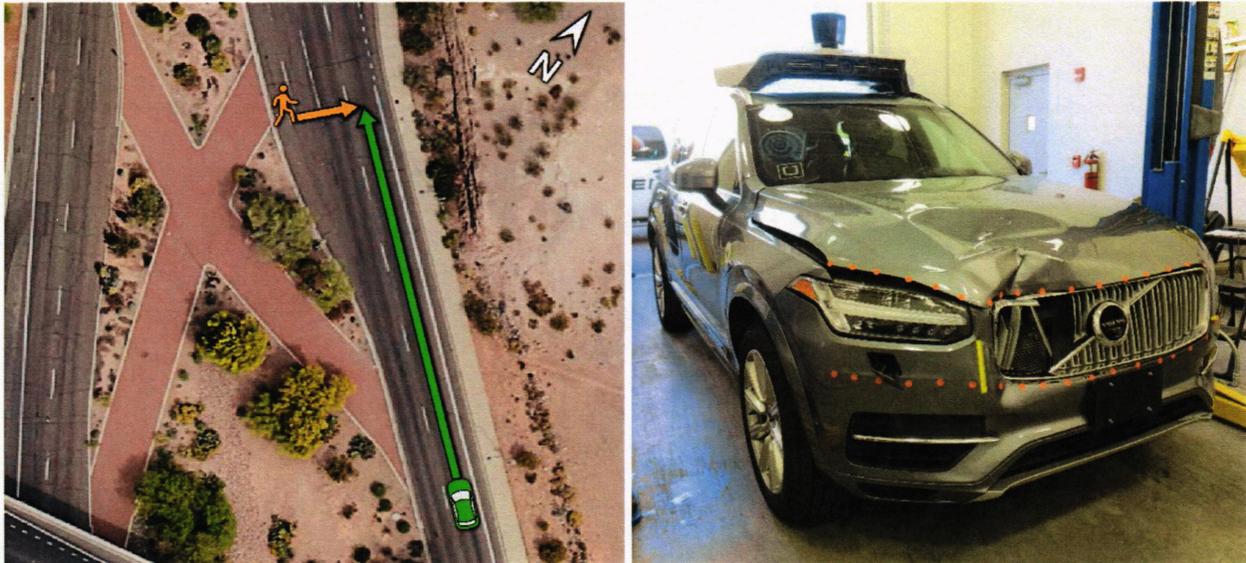
The crash occurred as the pedestrian, a 49-year-old female, walked a bicycle east across Mill Avenue. The Uber test vehicle was traveling in the right through lane when its right front side struck the pedestrian (see figure 1). As a result of the crash, the pedestrian died. The vehicle operator was not injured.

Figure 1. (Left) Location of the crash on northbound Mill Avenue, showing the paths of the pedestrian in orange and of the Uber test vehicle in green. (Right) Postcrash view of the Uber test vehicle, showing damage to the right front side.

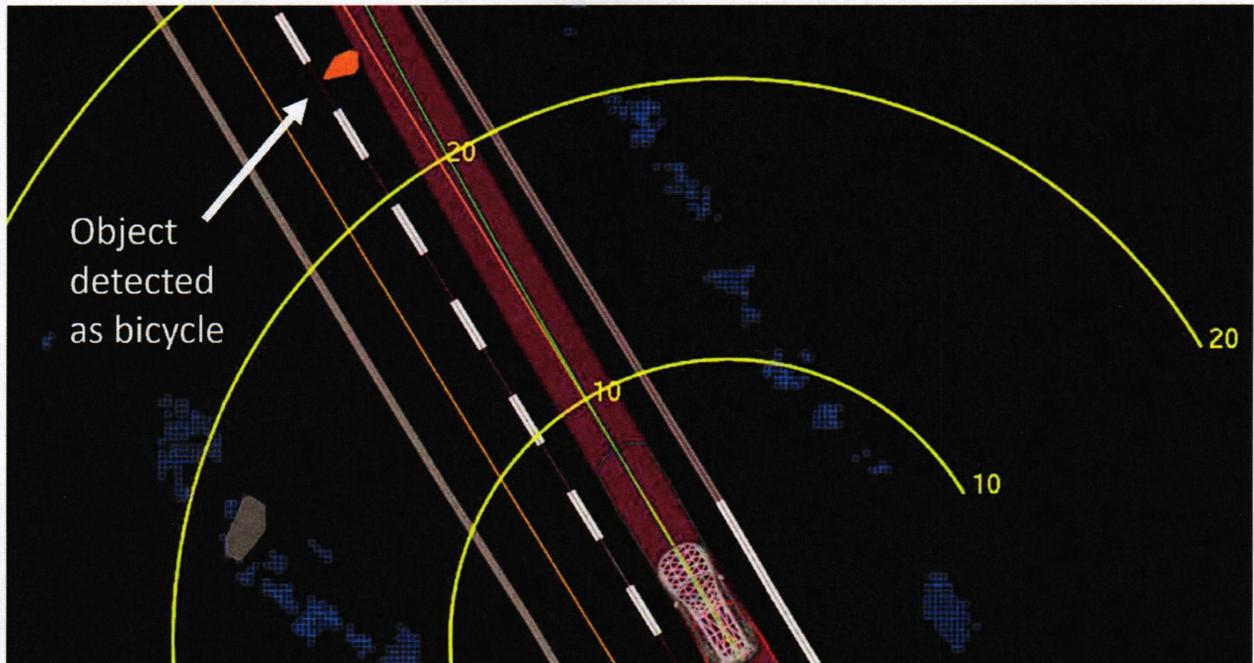
According to data obtained from the self-driving system, the system first registered radar and LIDAR observations of the pedestrian about 6 seconds before impact, when the vehicle was traveling at 43 mph. As the vehicle and pedestrian paths converged, the self-driving system software classified the pedestrian as an unknown object, as a vehicle, and then as a bicycle with varying expectations of future travel path. At 1.3 seconds before impact, the self-driving system determined that an emergency braking maneuver was needed to mitigate a collision (see figure 2).² According to Uber, emergency braking maneuvers are not enabled while the vehicle is under computer control, to reduce the potential for erratic vehicle behavior. The vehicle operator is relied on to intervene and take action. The system is not designed to alert the operator.

Figure 2. View of the self-driving system data playback at about 1.3 seconds before impact, when the system determined an emergency braking maneuver would be needed to mitigate a collision. Yellow bands are shown in meters ahead. Orange lines show the center of mapped travel lanes. The purple shaded area shows the path the vehicle traveled, with the green line showing the center of that path.
