Informational Summary Report of Serious or Near Serious CAL FIRE Injuries, Illnesses and Accidents

GREEN SHEET

Firefighter Fatality

De Luz Incident

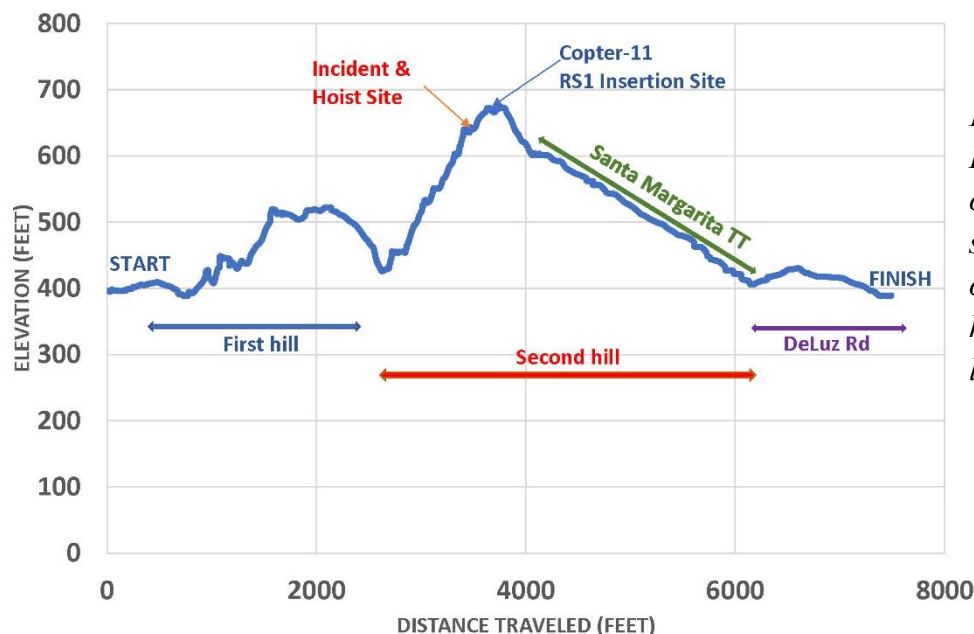
Figure 1-
*Elevation profile
of the hike
showing location
of incident and
hoist rescue
location.*

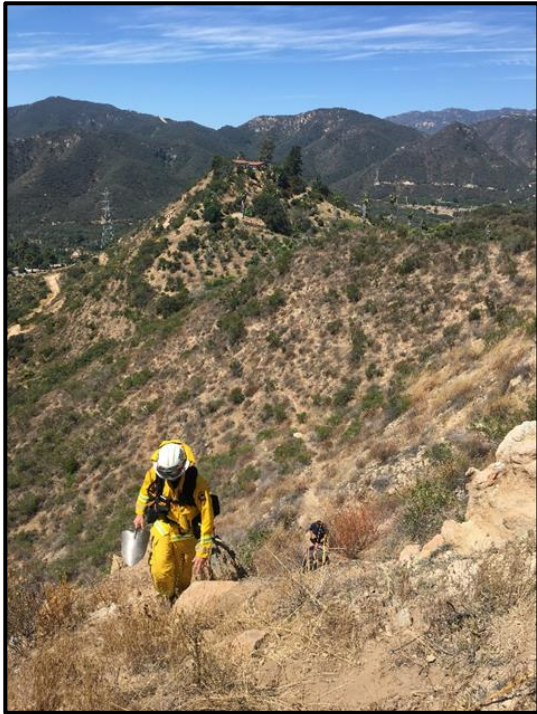
***Photo 1-** View from hiking trail looking west back down second hill from ridge.*

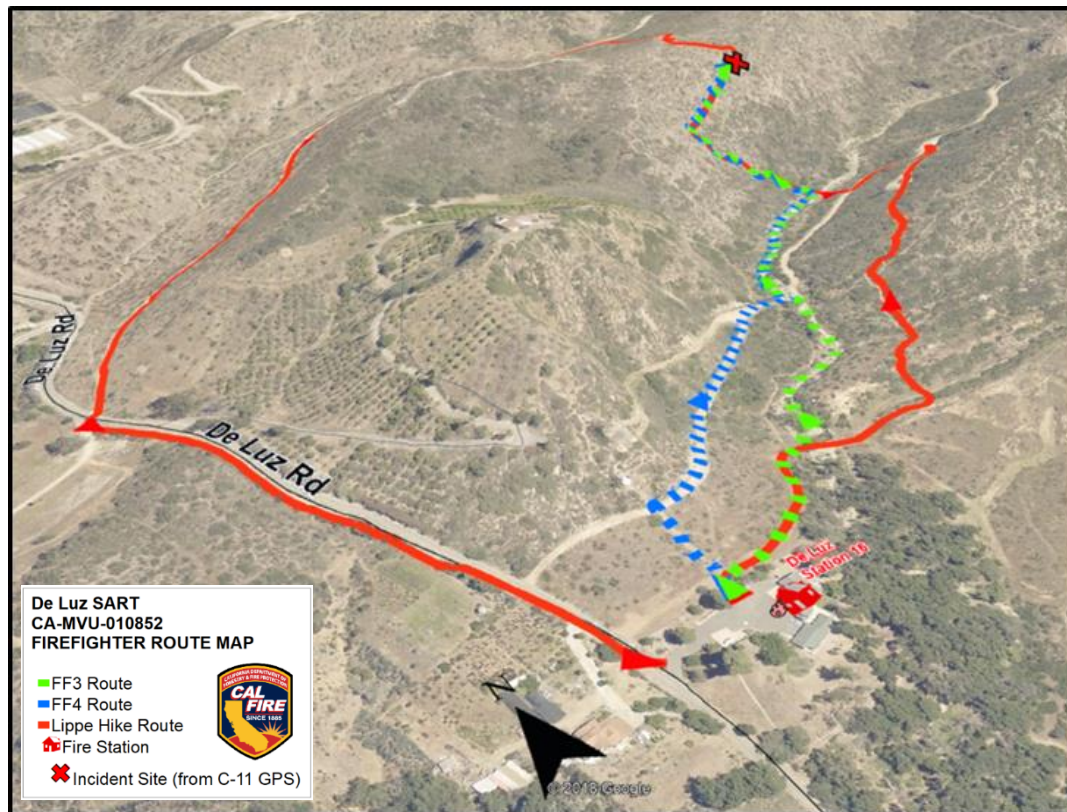
Aerial Imagery- Overview of hiking loop and incident site showing De Luz Fire Station (lower right) and route of travel of Firefighter 3 and Firefighter 4 to the ridge as part of the medical response.
