Sentinel Peak Road Safety Review – DRAFT 11/21/2018

SUMMARY OF ENGINEERING RECOMMENDATIONS BASED ON OBSERVATIONS

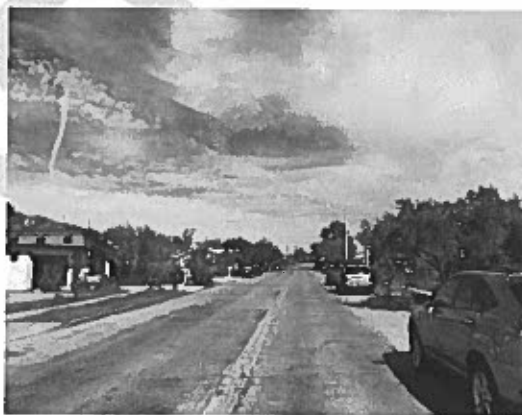
Speed hump recommended on Cuesta between Congress and Cedar.

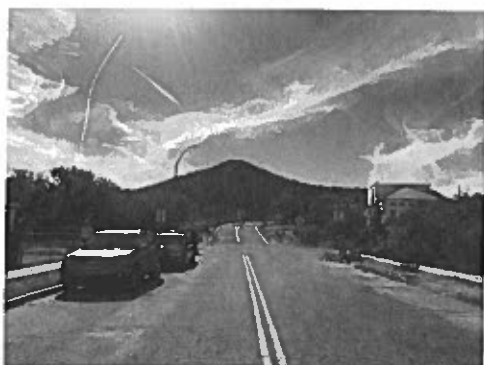
Neighborhood is working on a traffic circle and chicane.

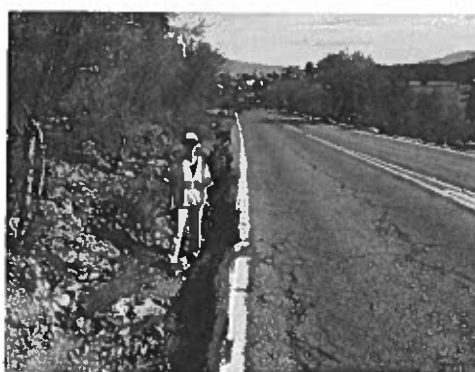
Steep drop-off demonstrated here.

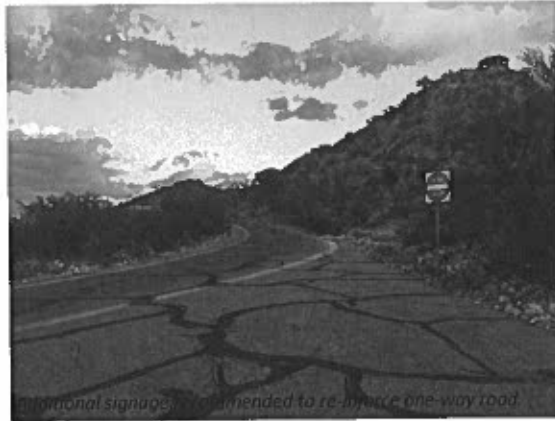
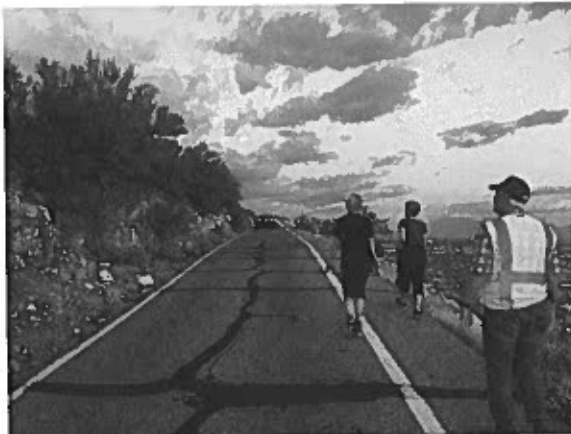
Guard rail segments, better object markers, and/or delineators recommended to better guide vehicles in the narrow road.

- Confirm lanes widths and consider 10-foot wide lanes to maximize shoulder space.
- Install KEEP RIGHT sign on uphill approach to 'Y'.
- Existing speed limit sign on uphill approach to 'Y' is on the left (wrong) side of the road.
- Install additional (both sides) DO NOT ENTER and WRONG WAY signs at the downhill road segment at the 'Y'.
- Consider marking a "turnaround" lane at the 'Y' directing vehicles back to the peak/upper lot. Include appropriate signage.

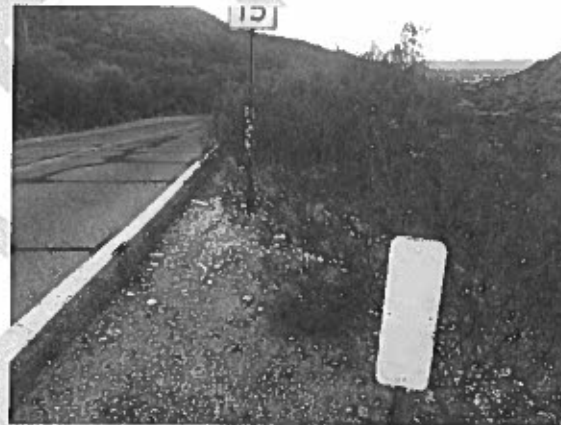
Object markers to be replaced.

- Trim vegetation throughout park as needed to improve sight distance, with special consideration to trimming at/near curves. Trimming will also help ensure people biking and walking are not forced into the travel lane.
- Restripe existing pavement markings.
- Replace all object markers (PVC and otherwise).
- Sweep sand/debris in the shoulder.
- Maintain the speed humps. [Streets Division is already aware of this and it should be complete soon.]
- Replace all damaged and worn signs.
- Adjust orientation of existing speed limit sign for drivers approaching the loop road.
- Evaluate pavement for needed maintenance (which would complement small changes to lane widths).

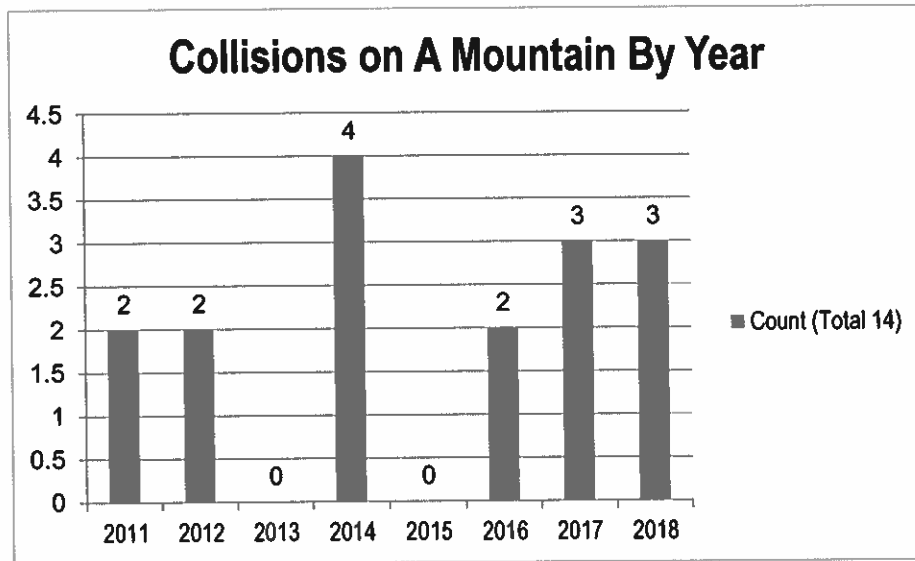
Collisions on A Mountain

This report provides a breakdown of collisions¹ that occurred in the area of A Mountain and S Sentinel Peak Rd. The data has been broken down into the total number of collisions by year as well as a list of the collisions.

Tucson Police Department has provided a summary of both traffic collisions reported and other types of incidences reported from 2011 – 2018 (as of October 19). TPD’s summary of the traffic collisions is attached as Exhibit A. The data shows there is an average of 2 reported collisions per year.

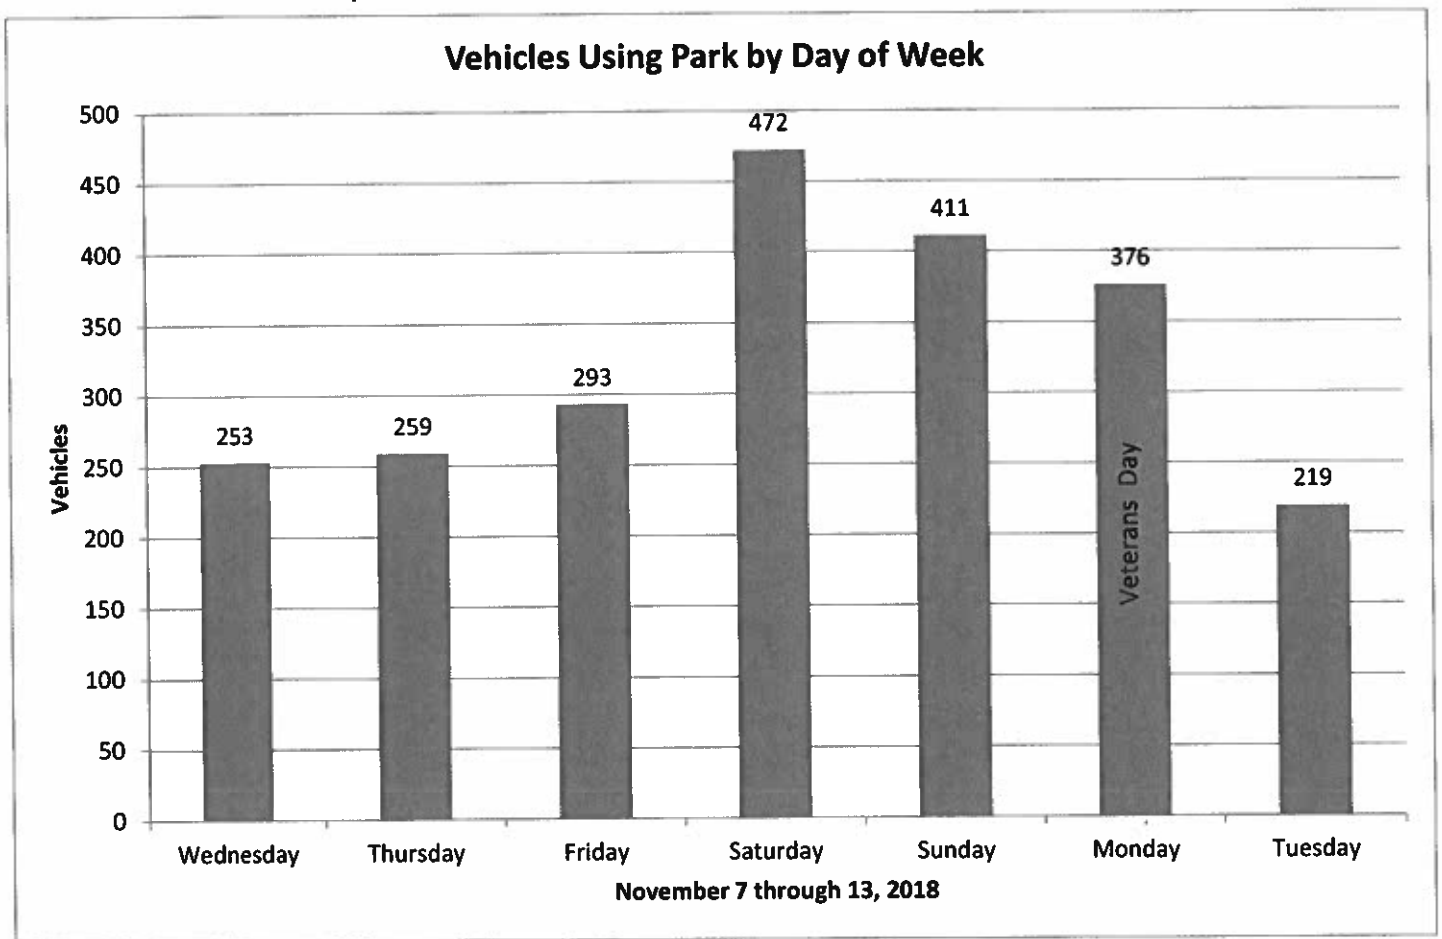
Exhibit B: Traffic Volume and Speed data for Sentinel Peak and Cuesta Roads. Data collected November 7 – 13, 2018.

- 2,283 vehicles entered Sentinel Park over a week period
- Saturday and Sunday are the busiest days
- Tuesday and Wednesday were the least busy days
- Average of 256 cars per day during the week (Tuesday – Friday)
- Average of 441 cars per day during a weekend day
- Evening time (4-6 p.m.) is the busiest time for vehicles.
